Project/File: 310206053

Date: 17 December 2025

Reference: Skippers Bridge Cables**Executive Summary**

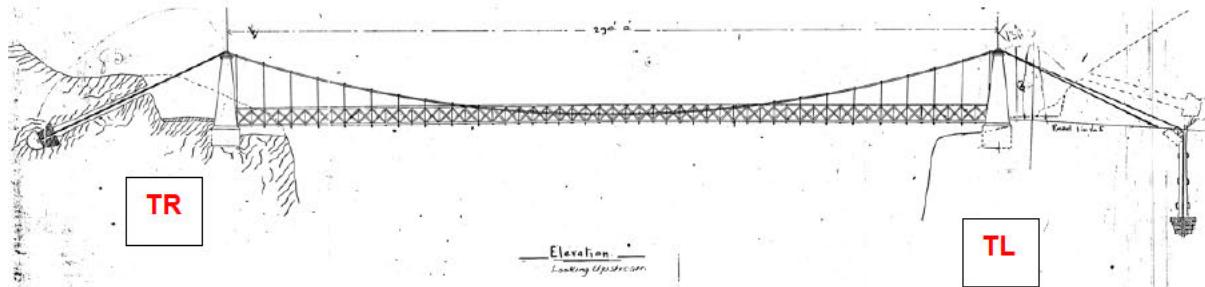
Figure 2. Original Construction Drawings showing cable anchorages

There has been concern regarding the suspension cables for the Skippers bridge for some time. The cables on the True Left (TL) side pass over a steel 'roll over' plate and then drop vertically into a shaft where they are anchored around a dead man. The cables on the True Right (TR) are anchored to a deadman of unknown detail. This layout is shown in the original construction drawings below.

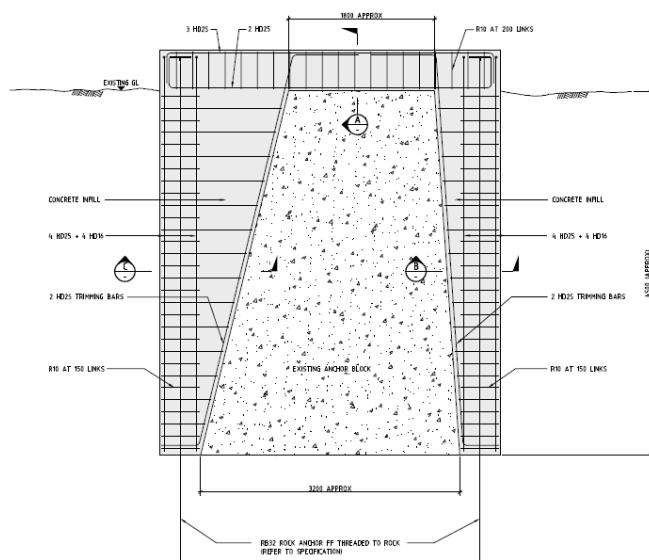
Figure 7. Rock bolted hold down block on the TL cable anchorage.

The blocks intended to hold down the cable anchorage on the TL are shown in the photograph in Figure 4 and a section of the drawings is shown below.

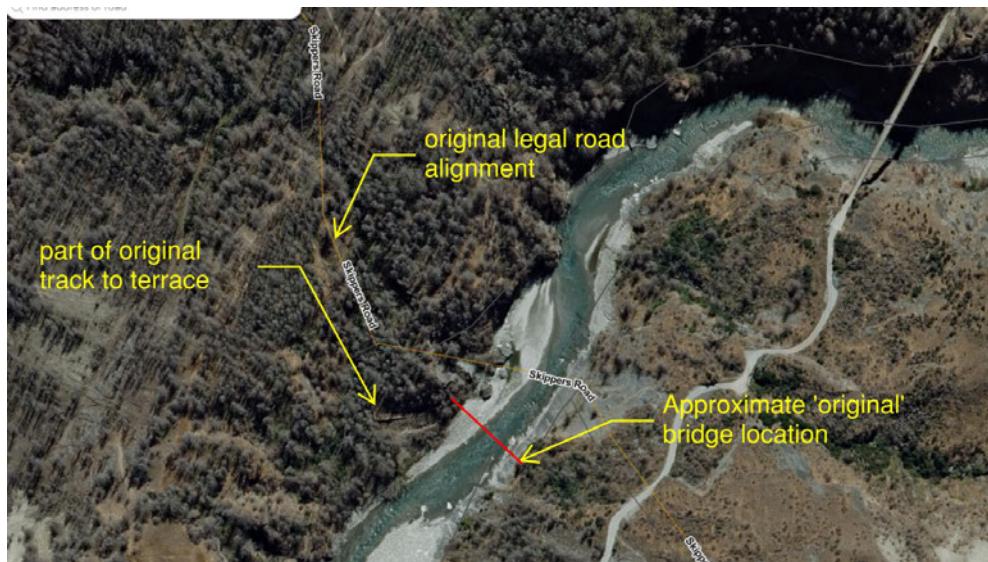
Figure 14. Location of 'original' Skippers Bridge

The final alternative considered is to construct a new pedestrian suspension bridge at the beach 300m downstream of the existing bridge. This would be in the location of the 'original' pre 1900 bridge. This location is indicated below:

3. Construct a new pedestrian bridge in the 'original' 1890 alignment downstream of the existing.

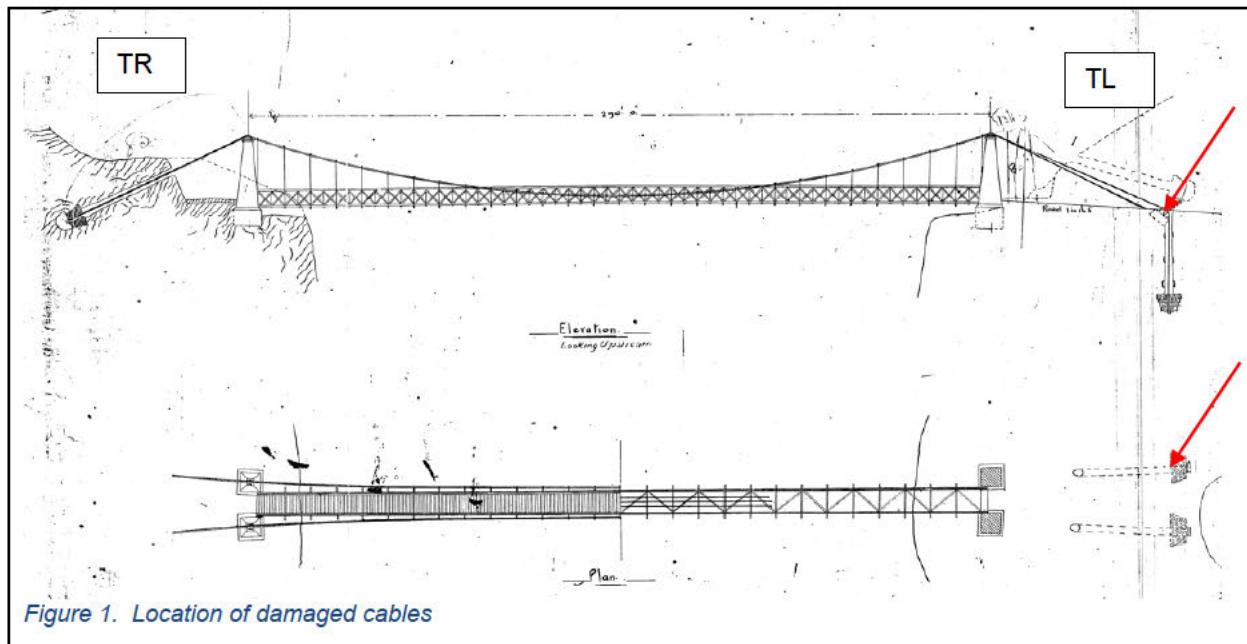
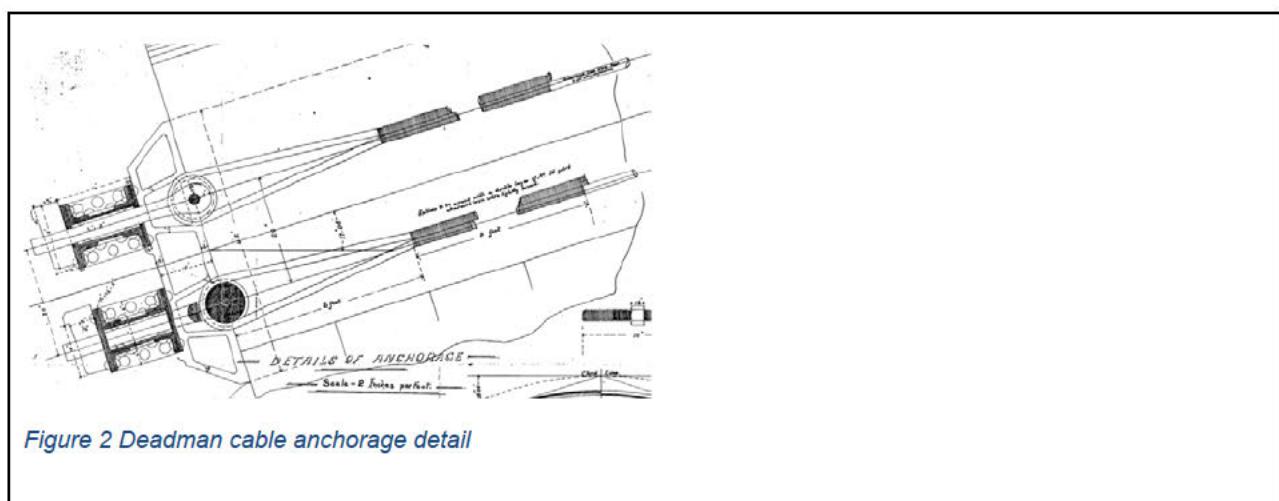
On the TR (True Right) the cables are believed to be anchored in inclined tunnels which are sloped to match the cable angle. On the TL the cables are draped over a steel plate roll over and then drop vertically down to the cable anchorage in a shaft.

The cable anchorage consists of a deadman cast into a vertical shaft.

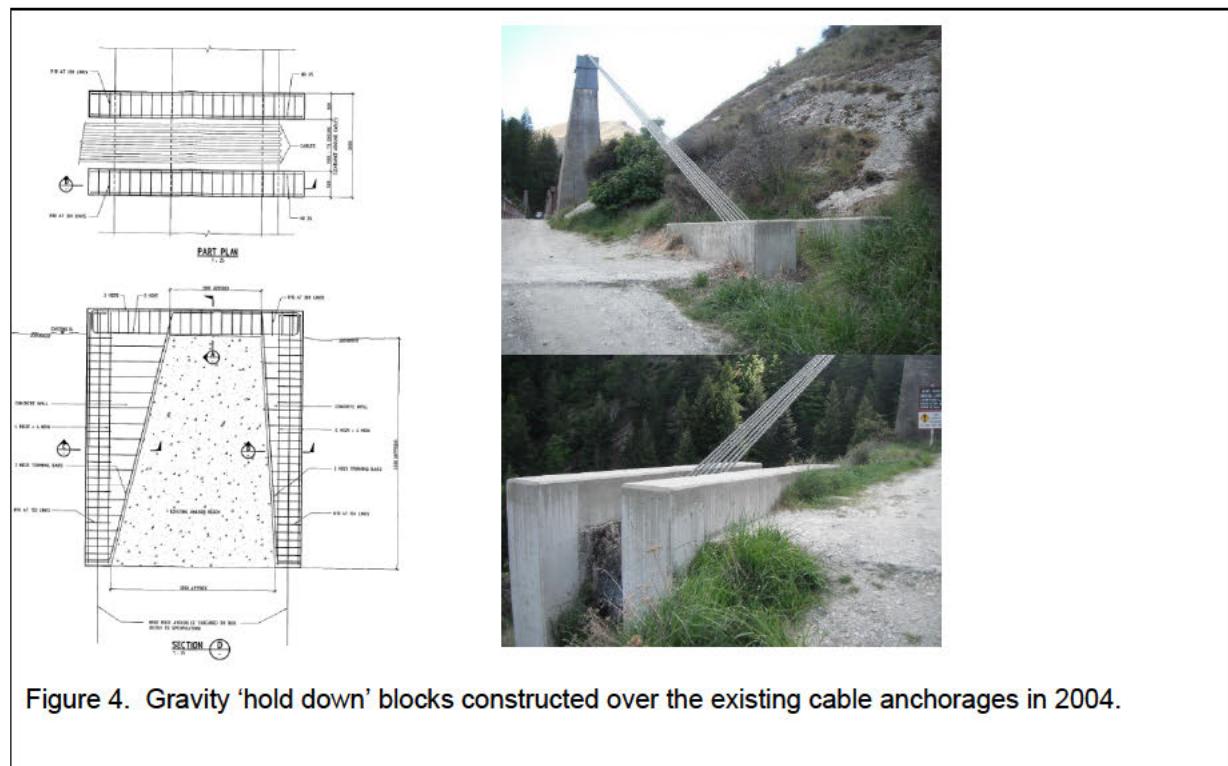
Figure 4. Gravity 'hold down' blocks constructed over the existing cable anchorages in 2004.

In 1995 it was noted that the stoney roller bearings on the true left (TL) towers of the Shotover Bridge were displaced by approximately 100mm towards the centre of the bridge. The specific cause of the displacement of the bearings was not identified, but the displacement is indicative of relaxation of the cable anchorages on the TL side. In 2004 the TL cable anchorages of the bridge were stabilised with concrete blocks constructed over the existing cable anchorages to add additional resistance to relaxation of the cables. These blocks are shown in the figure below.

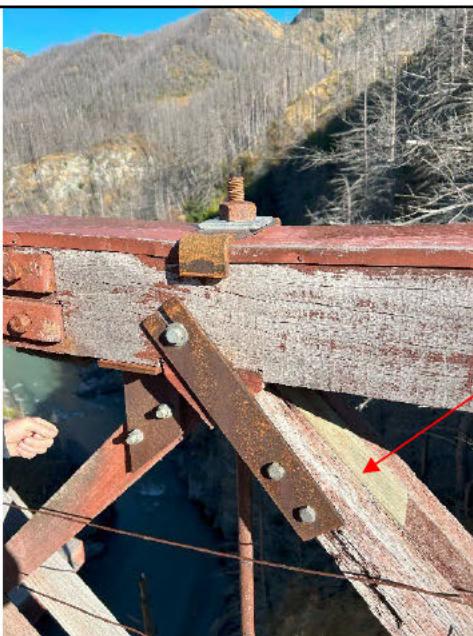
- Diagonal truss members made from pine may be understrength. The report identifies both tension and compression failure in these members.
- The report identifies that the test load procedure tested only the transoms near the middle of the bridge span and did not test the capacity of the transoms at the end of the span.

Pine blocking added between original hardwood struts

Figure 13. Truss cross bracing connection with location plate and pine blocking arrowed. This connection is capable of resisting compression forces in the struts only.

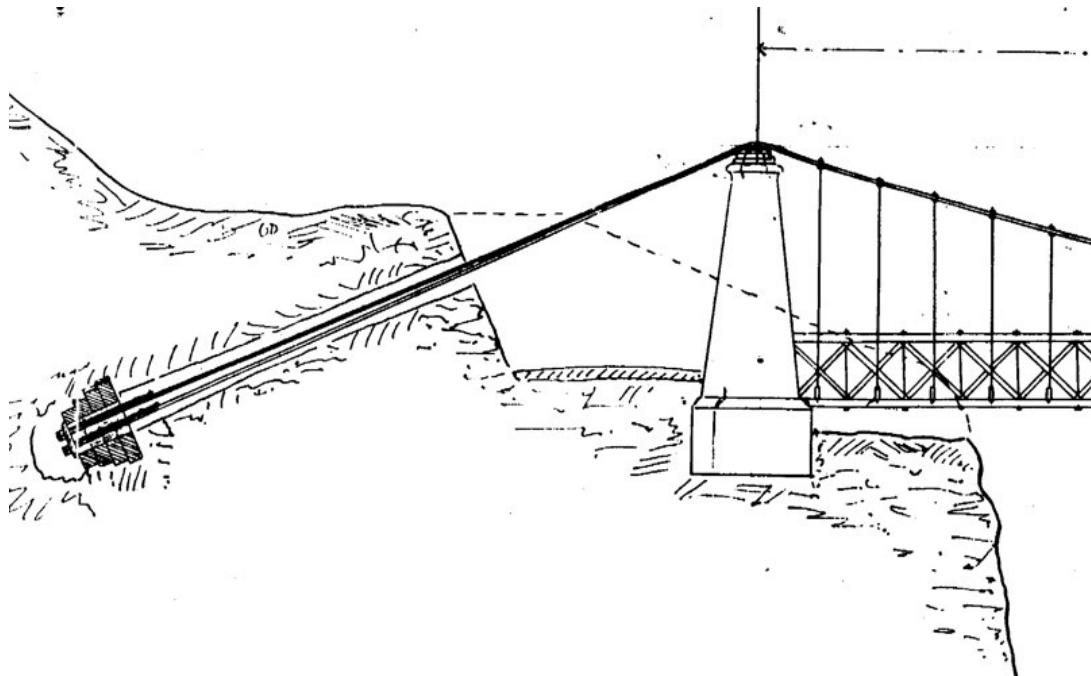
The cable anchorages on the TR are not visible. The cables disappear into the site soil. The drawings indicate an angled dead man anchor in a tunnel, but the drawings available do not include either details or dimensions of the anchorage. Relevant sections of the drawings available are shown below.

Figure 14. Unspecific drawing showing TR cable anchorage

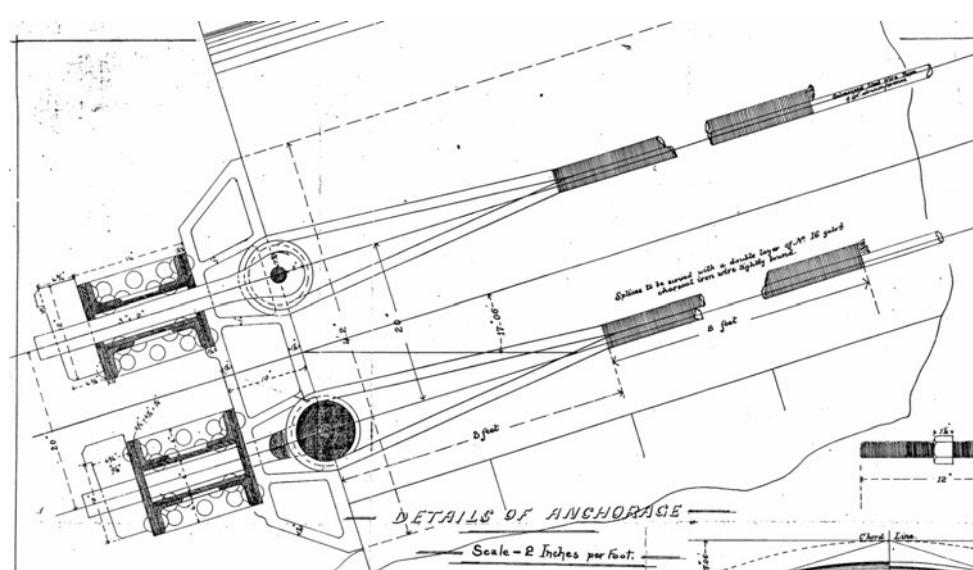
Figure 15. Deadman anchorage. Text reads “splices to be scried with a double layer of no. 16 galv'd charcoal iron wire tightly bound”

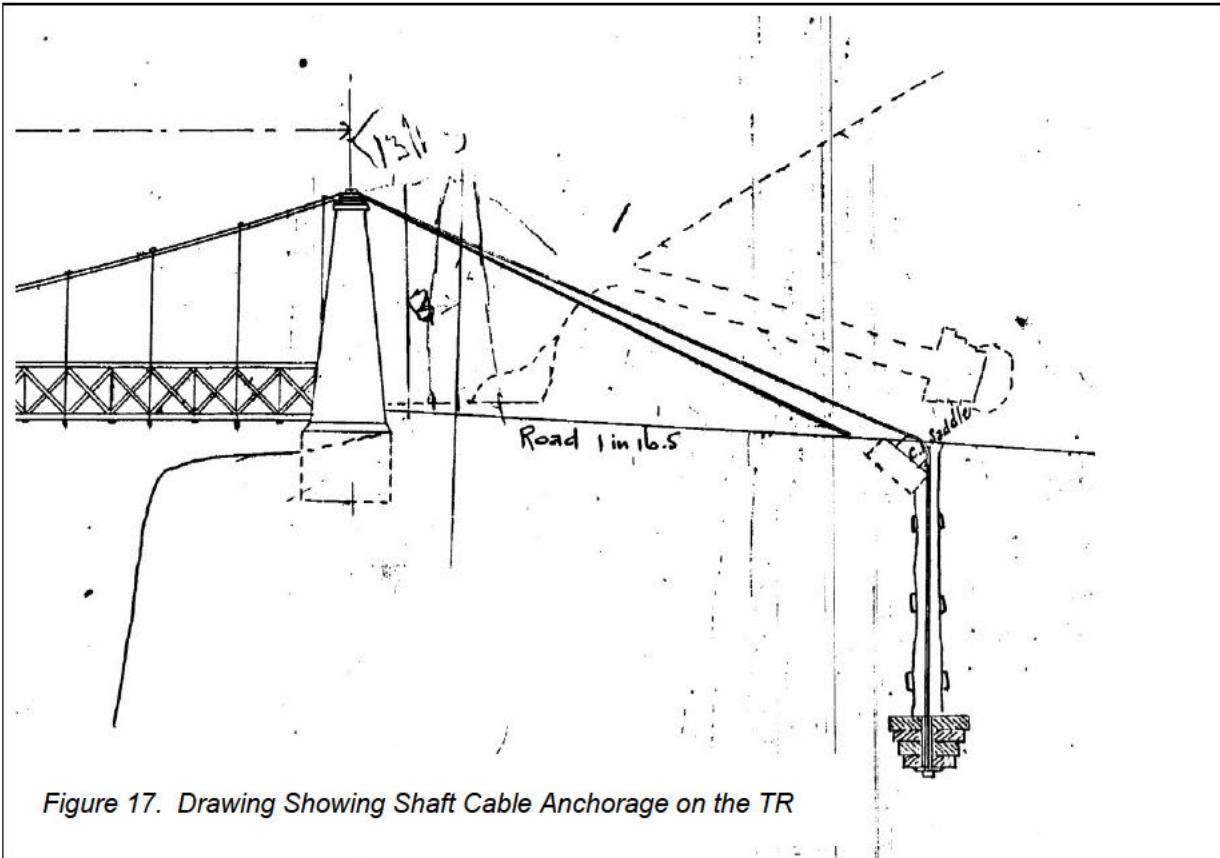
Figure 17. Drawing Showing Shaft Cable Anchorage on the TR

On the TL the cables are anchored in vertical shafts, and the drawings indicate a similar deadman anchorage detail as the TR. Again, there are no dimensions or specific details in the drawings available. As previously noted, it was believed that the cable anchorages on the TL were relaxing and allowing the cable to slacken and consequently move the bearings on both TL towers. Concrete blocks were constructed over the anchorages in 2004 to prevent further relaxation of the anchorages. Corrosion of cables near the ground is visible in both the upstream and downstream TL anchorages. This is shown below.

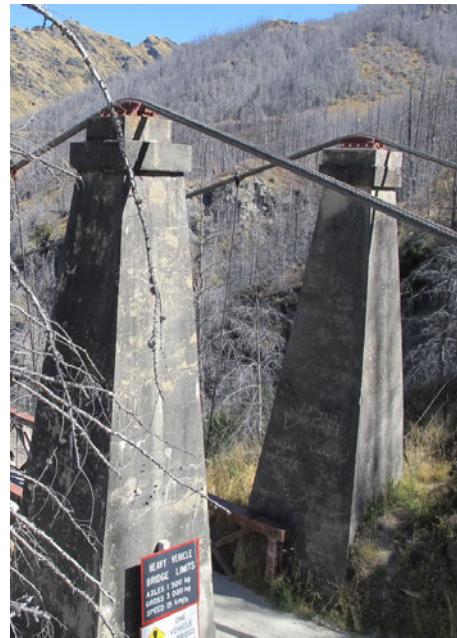
Figure 25. TR towers – these TR do not have stone capping blocks although historical photographs suggest that all four towers originally had basalt capping blocks.

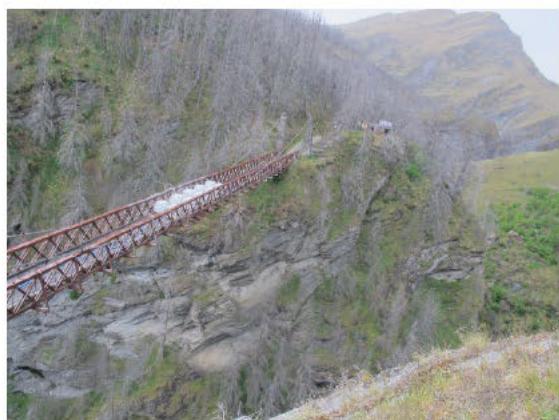
Figure 28. TR abutment rock photographed from upstream

The tower foundations on both abutments are close to the cliff edge. There appears to be a risk of block failure beneath the towers on both sides of the bridge, particularly in an earthquake. It is considered unlikely that these foundation conditions would meet current standards. Consequently, if the bridge is completely replaced, stabilising work is likely to be required at the tower locations and this work will be a significant expense. Stantec consider it is unlikely that a bridge design in this location, without significant stabilisation work, would pass peer review and consequently a building consent application for a complete replacement is unlikely to be approved. The tower foundation conditions are shown in the figures below.

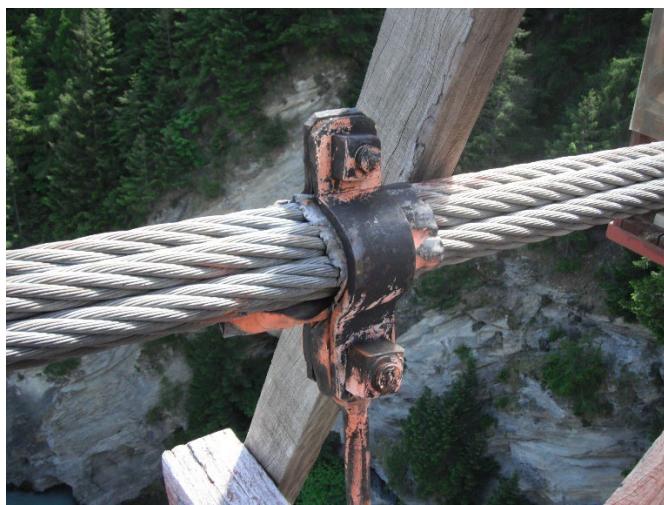
Figure 31. Top section of hanger

The hangers are generally in good condition and no significant deterioration or loss of section in the hangers has been detected. The hangers are shown below.

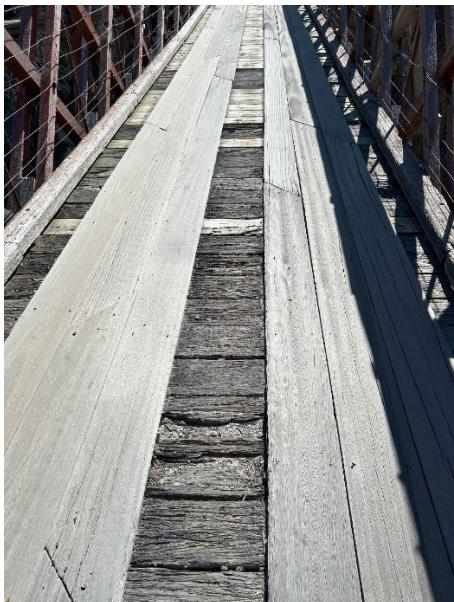
Approximately 50% of the hardwood deck planks have been replaced with pine recently and the pine planks are in satisfactory condition. The remaining Hardwood deck planks are generally in poor condition, and we anticipate that replacement of the remaining hardwood deck planks will be required within the next ten years. The selection of whether the deck planks are replaced with imported renewable Australian hardwood or pine remains to be made. Pine planks are softer and less strong than hardwood. The deck planks are shown in the figure below.

Figure 39. bridge deck consisting of both pine and hardwood planks
