**Geotechnical/Natural Hazard  
Assessment  
Three Parks Land, Wanaka**

**March 2007**

Date: March 2007  
Reference: 6CWM03.46 006DD  
Status: FINAL

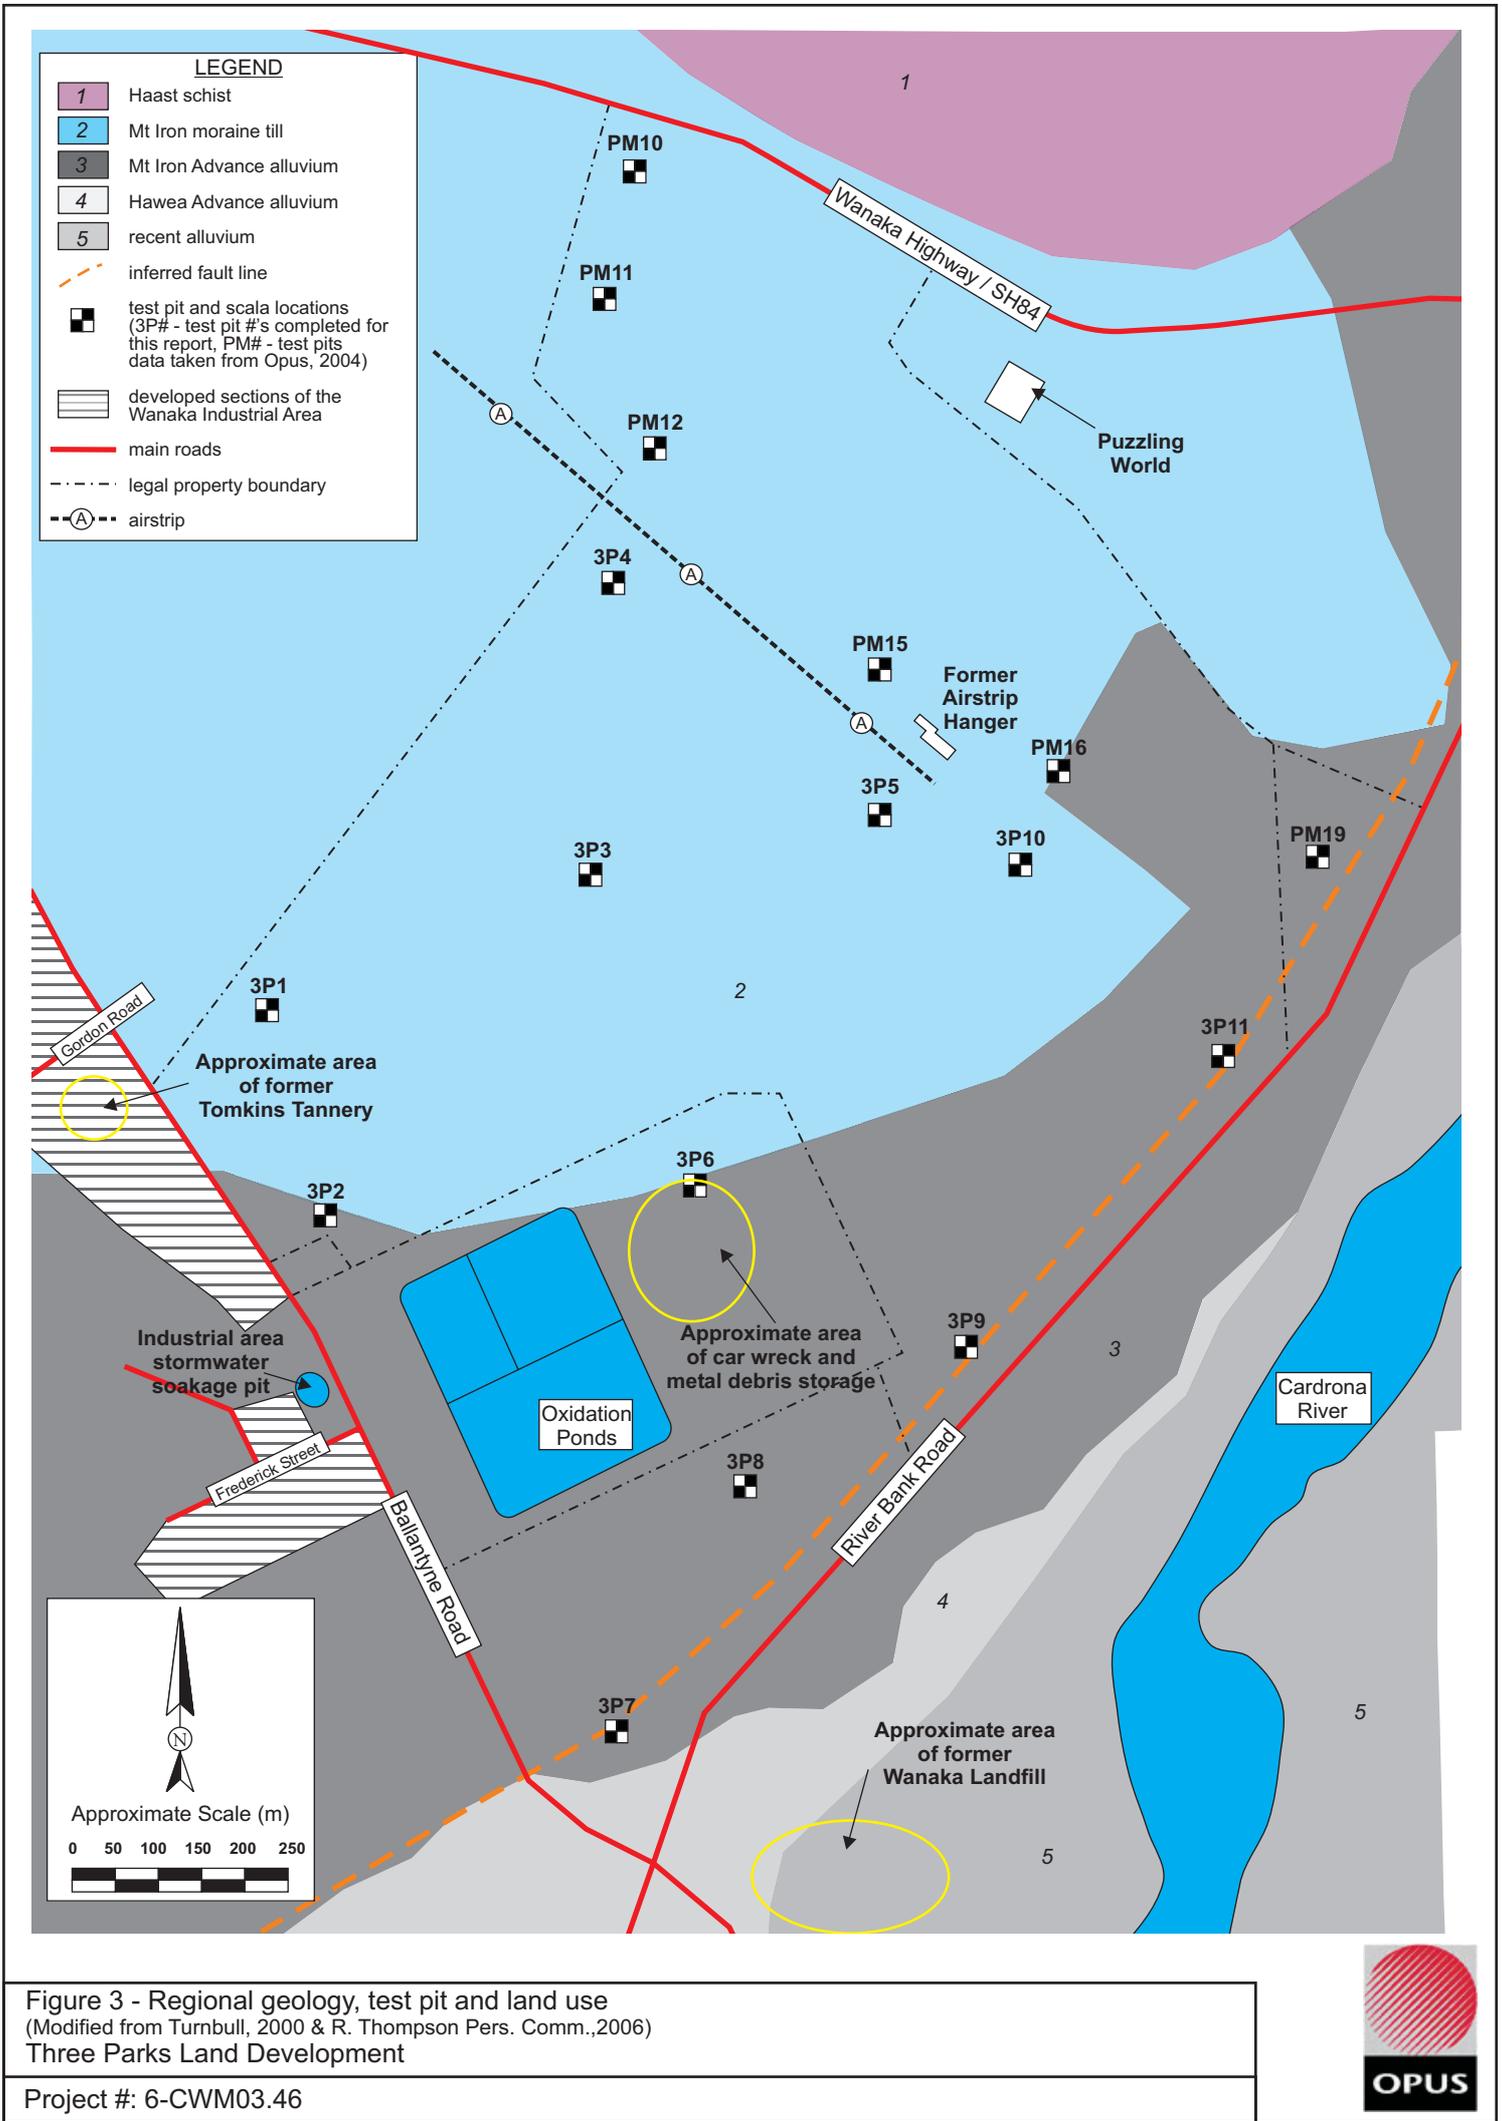
The majority of the site comprises tills and outwash gravels from the Mount Iron moraine deposit (refer to Figure 3). There is a small area along the eastern margin of the site where deposits represent alluvial deposits associated with the Mt. Iron moraine and glacial advance. The Mt. Iron moraine deposit and related Mt. Iron alluvial deposits are assumed to be approximately 23,000 yrs old (R. Thompson, Pers Comm.). A small slither of land to the south east of the site comprises of alluvial deposits of the Hawea Glacial Advance (~15ka).

Test pits excavated on-site revealed alluvial and glacial fan and till deposits, most pits comprised mainly sandy gravels, with some sands and silts. The results of these can be found in Appendix A.

Figure 3 - Regional geology, test pit and land use  
 (Modified from Turnbull, 2000 & R. Thompson Pers. Comm., 2006)  
 Three Parks Land Development

Subsurface investigations consisting of test pits and scala penetrometer tests were undertaken at 11 locations on the site as shown in Figure 3 (test pit logs are presented in Appendix A). The test pits were excavated with a 6 tonne digger to depths of 3 m. In addition, 6 test pits to depths up to 5 m were excavated at the northern end of the site during the Geotechnical investigations into the Queenstown Lakes District Council Cardrona Stormwater Bypass (Opus, 2004).

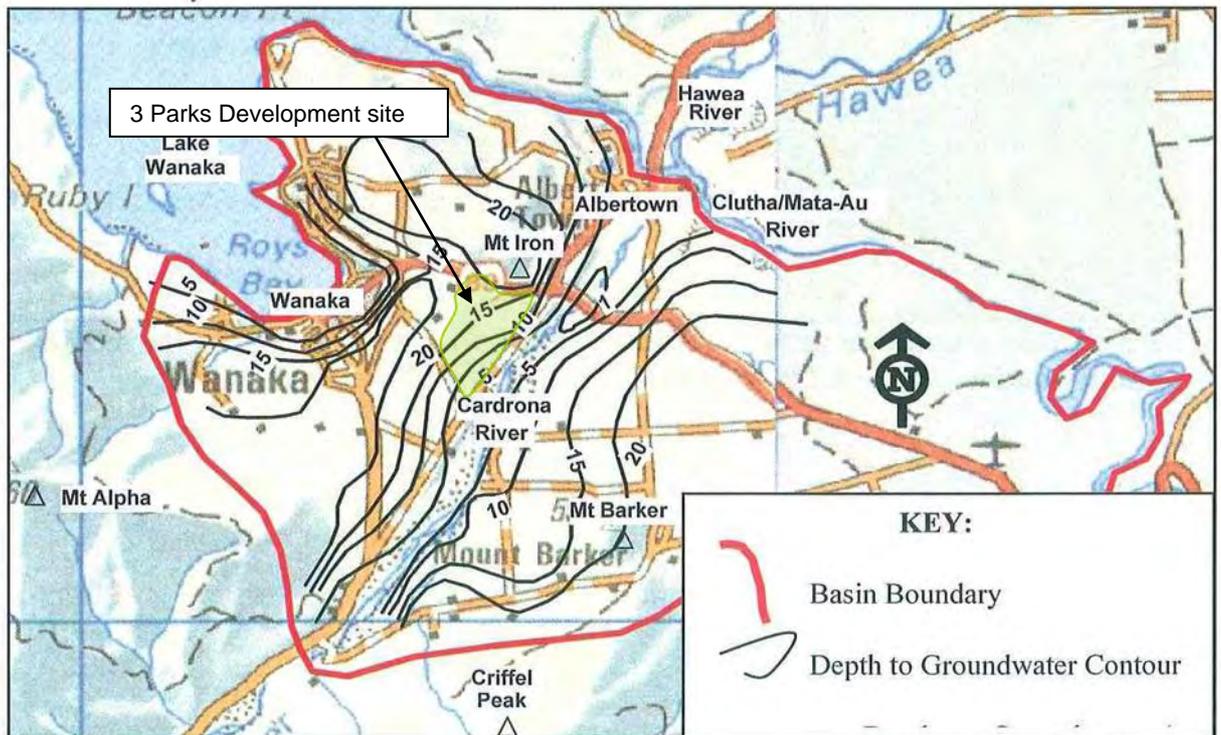
The water table varies considerably across the site and is highest, ~ 5 mBGS (meters Below Ground Surface), adjacent to the Cardrona River. At the northern end of the site groundwater is much deeper, ~ 20 mBGS, as shown in Figure 4. There are 198 wells located within the Wanaka Basin Aquifer that are currently being used for drinking water supply, irrigation, commercial, scheme water supply and stockwater uses. There are a number of wells (> 5) located within the site with known uses including irrigation and drinking water supply.

Figure 4 – Depth to water table for the Wanaka Basin in metres below ground level (m BGL) during July 1999. The Three Parks Development Area is highlighted in green. Scale approximately 1:120,000 (ORC, 2003).

As discussed in section 3.3 and 4.2, no groundwater or perched water were observed in any test pits excavated on site. Information gathered from the Wanaka Basin Groundwater Modelling Report (ORC, 2003) show that the groundwater table on site varies from between 5 and 20 m below ground level (Figure 4). Liquefaction is unlikely to occur in sediments where the groundwater table is at depths >12m
