LOTS 1 - 5 BEING A PROPOSED SUBDIVISION OF  
LOT 1 DP 396356 - THE DENE, HAWEA  
SITE DETAIL & NATURAL GROUND LEVELS

LOTS 1 - 5 BEING A PROPOSED SUBDIVISION OF  
LOT 1 DP 396356 - THE DENE, HAWEA  
PROPOSED ACCESSWAY LOCATION

# Natural Hazards Assessment

# Environmental Management Plan (Rev A)

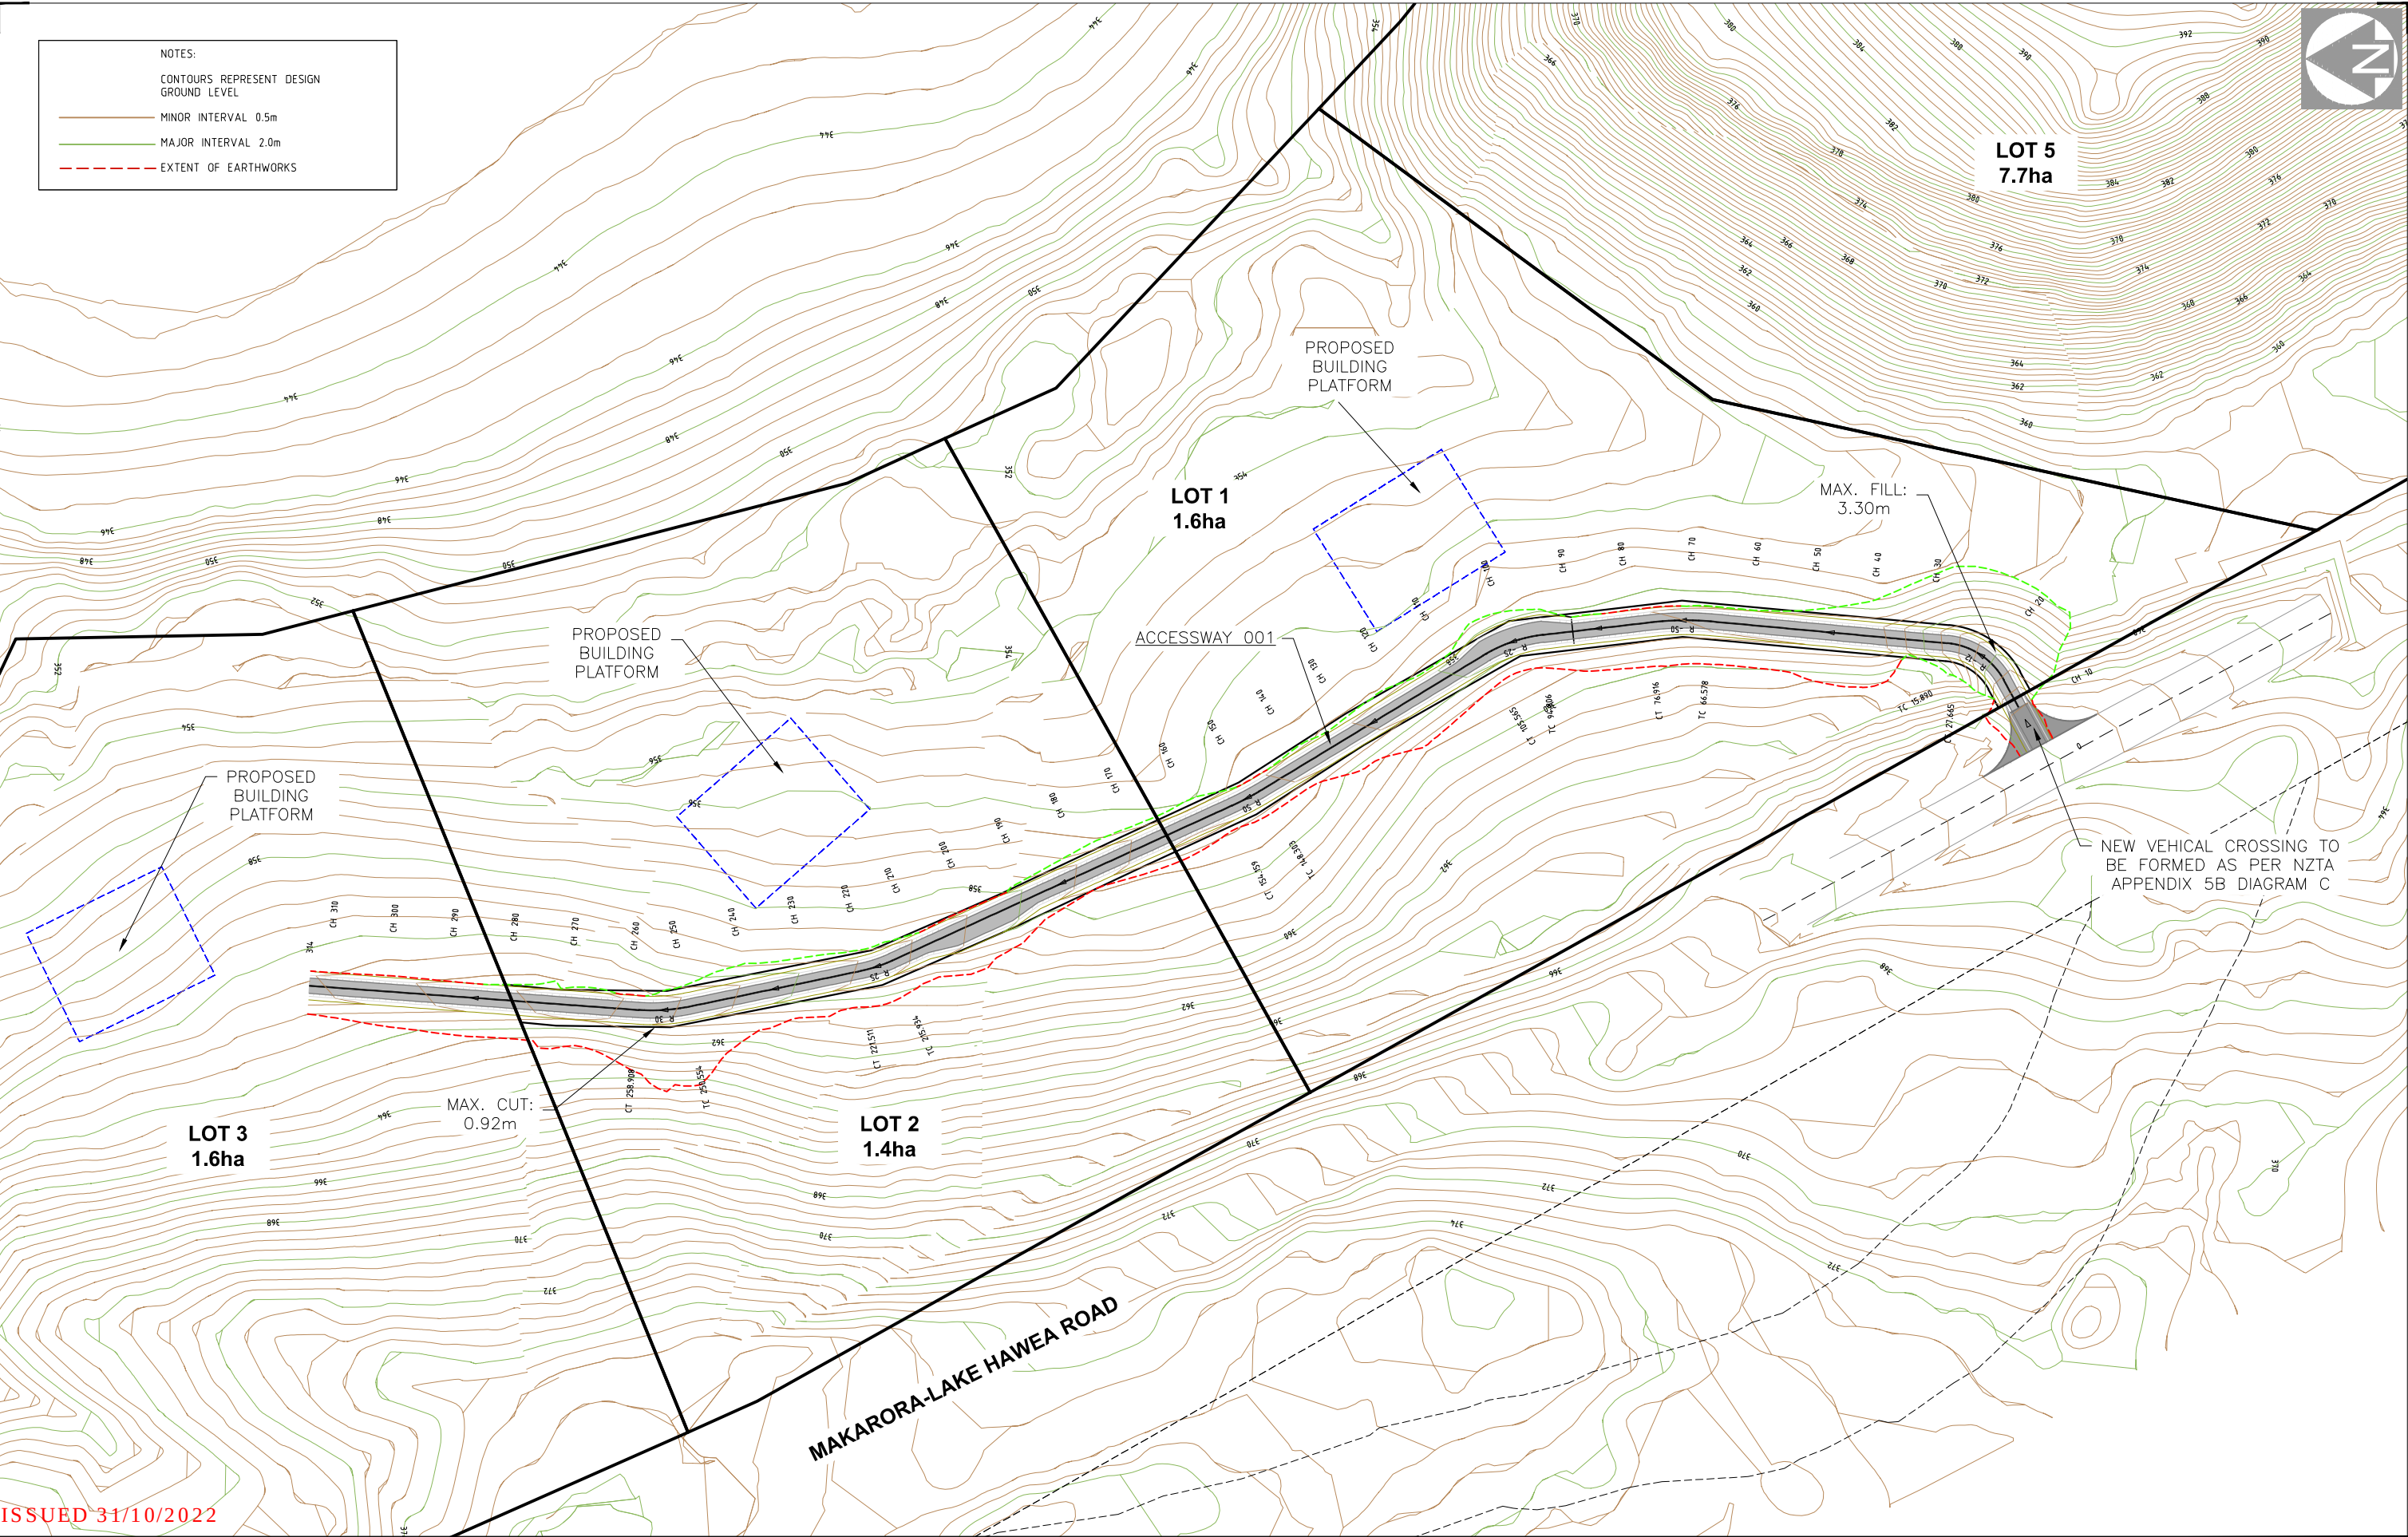
NOTES:  
CONTOURS REPRESENT DESIGN  
GROUND LEVEL  
MINOR INTERVAL 0.5m  
MAJOR INTERVAL 2.0m  
EXTENT OF EARTHWORKS

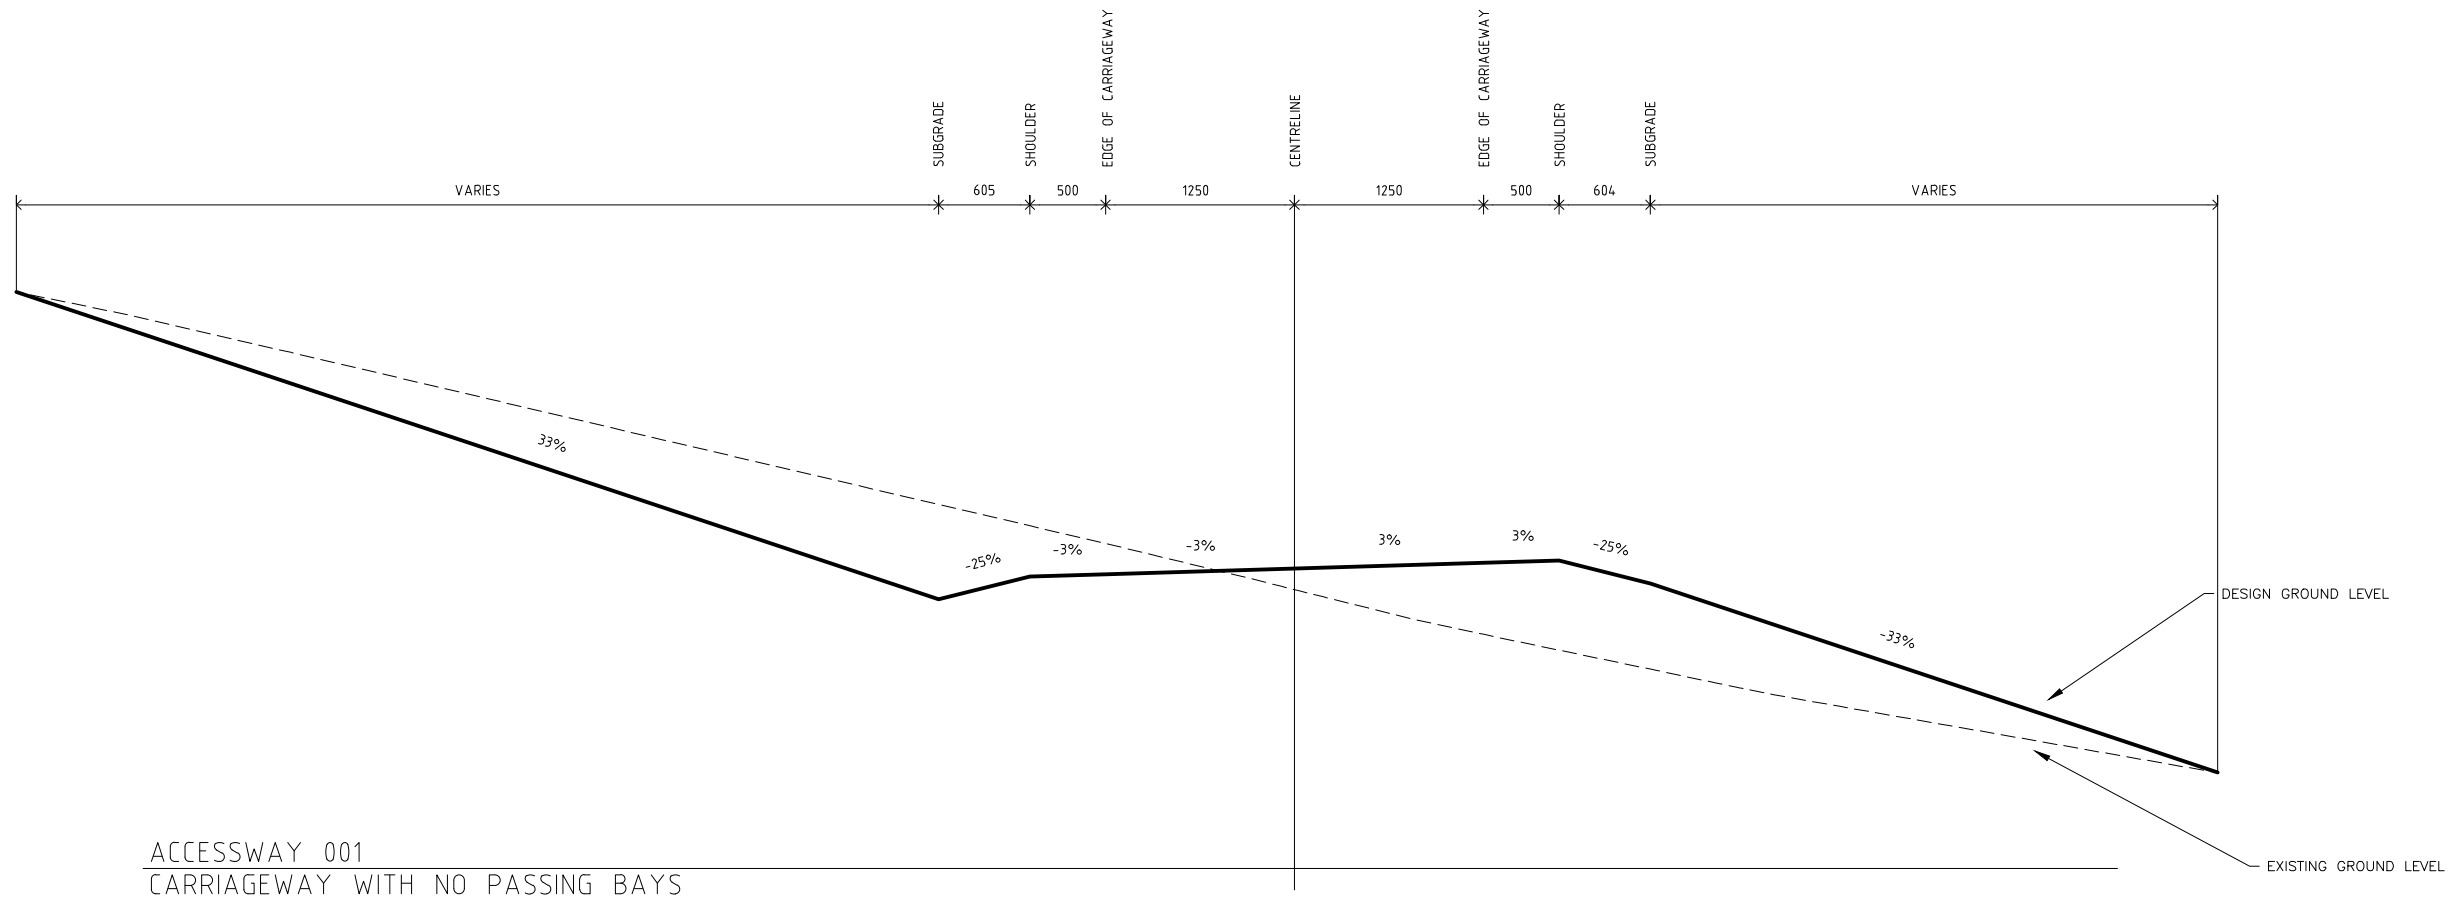
ACCESSWAY 001  
CARRIAGEWAY WITH NO PASSING BAYS

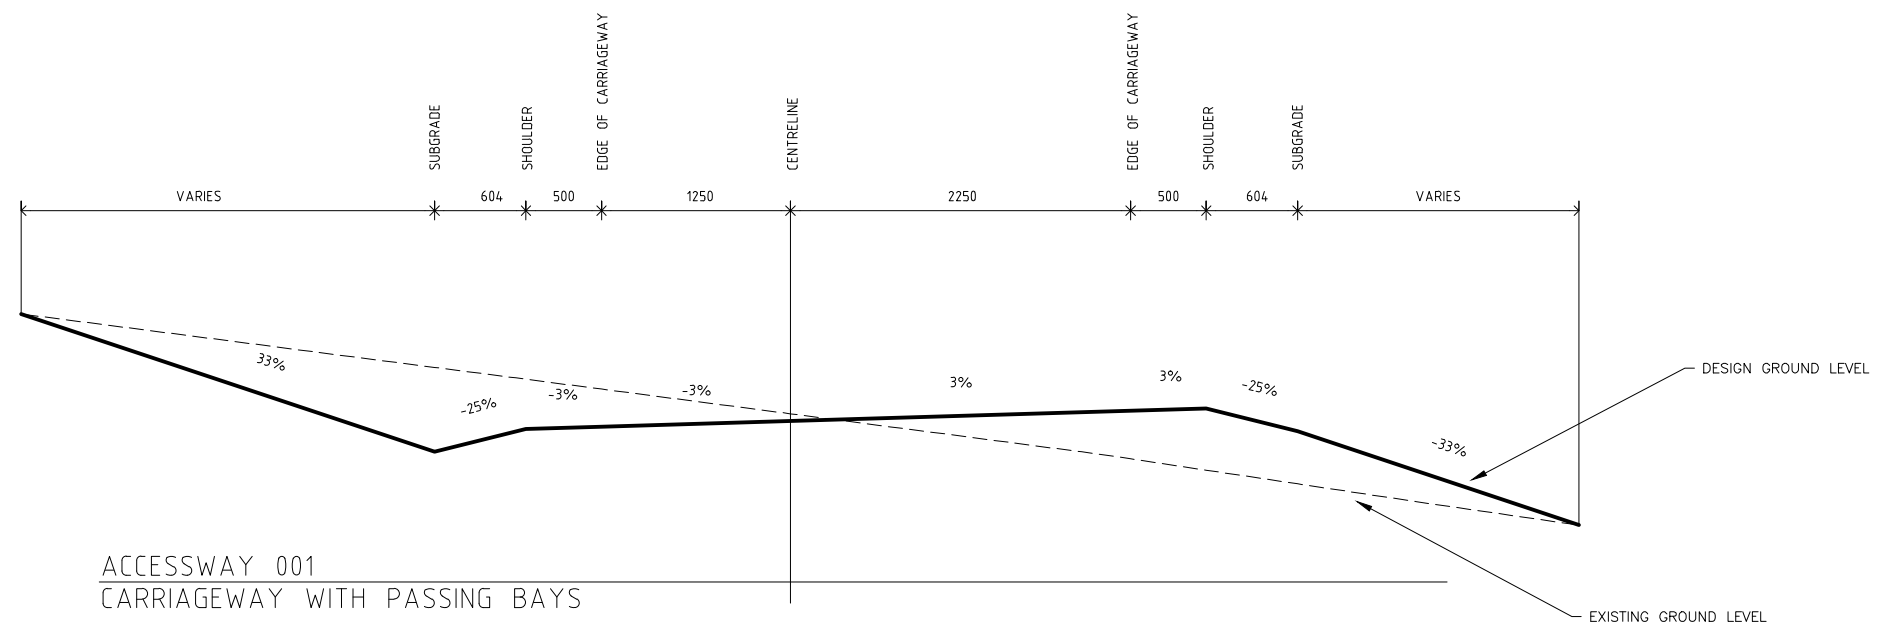
ACCESSWAY 001  
CARRIAGEWAY WITH PASSING BAYS

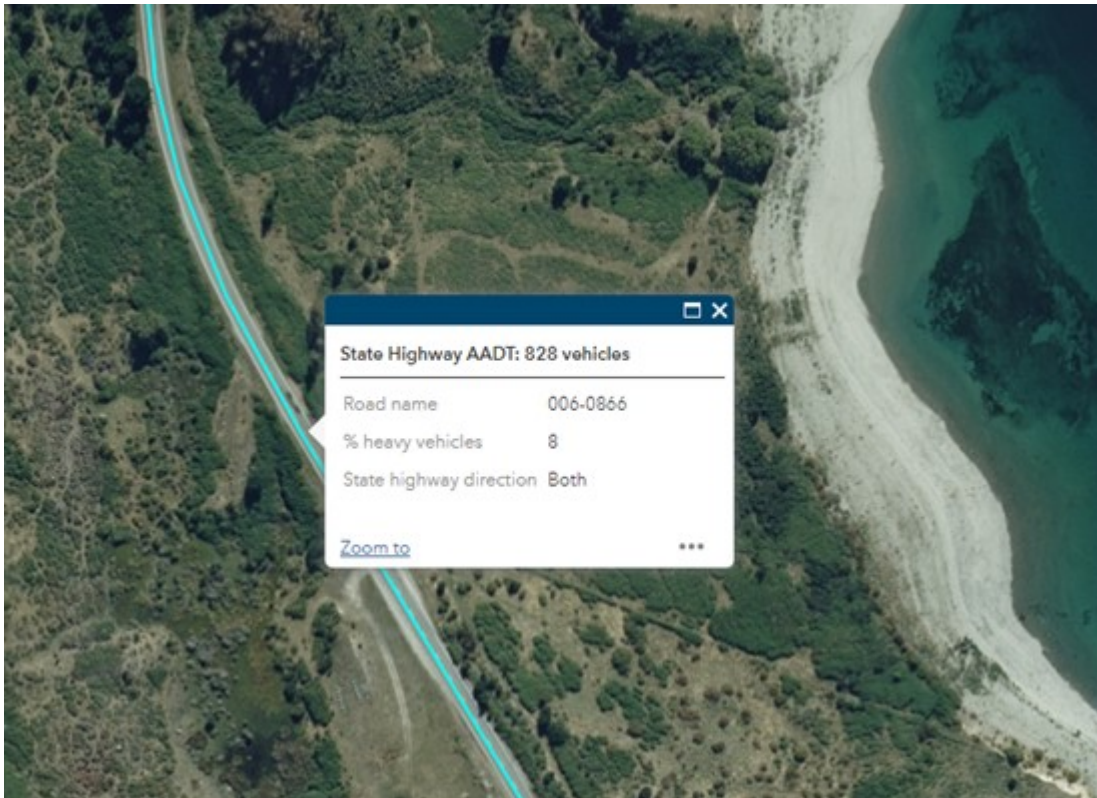
We propose to access three lots of the accessway. Allowing for 8 equivalent car movements per lot this will give is 24 movements per day.

Reading Appendix 5b from the NZTA Planning Policy Manual we would require a Diagram C standard crossing.

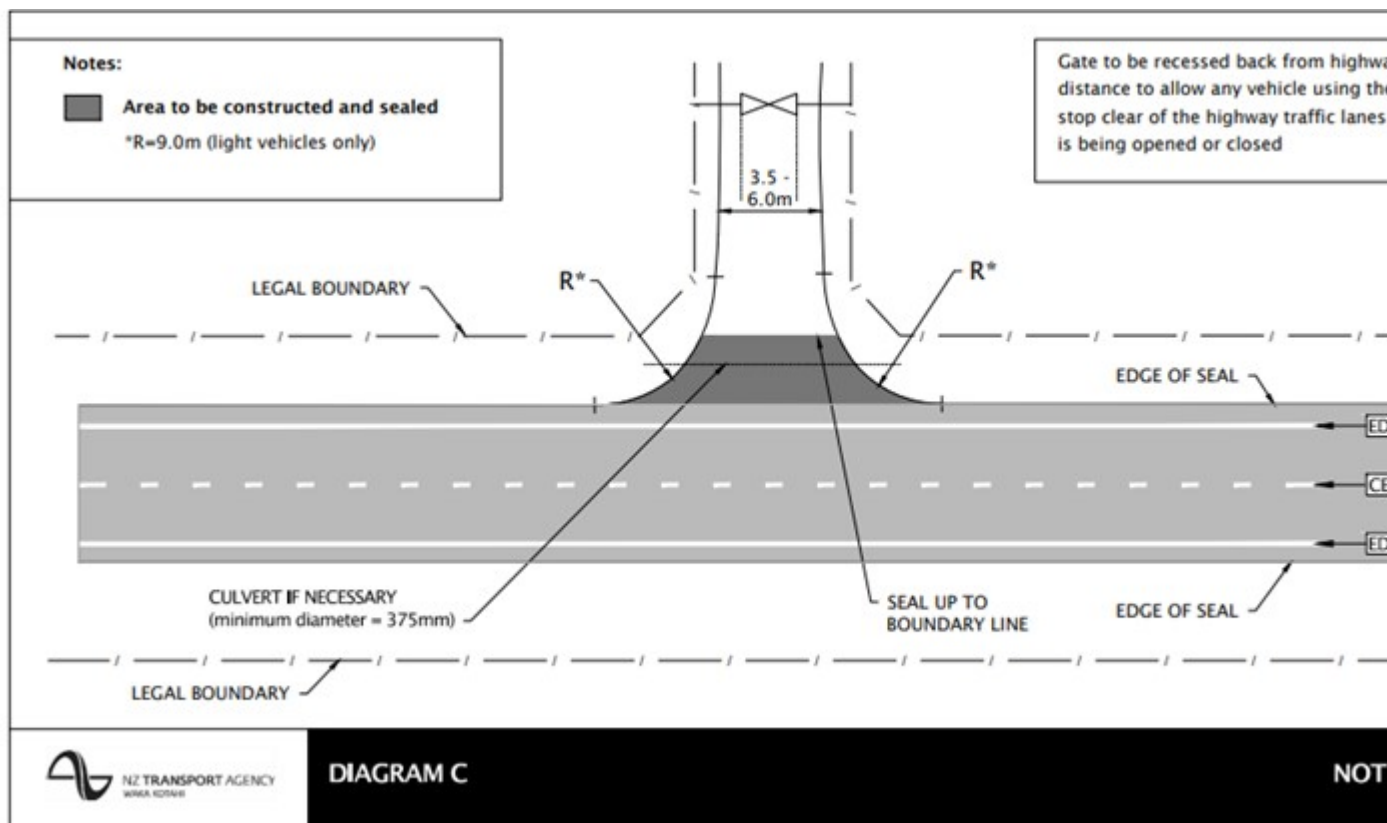
Other  
accessway  
geometric  
design detail

Guidance on other aspects of accessway geometric design, such as the requirements where culverts are likely to be needed to accommodate a watercourse or drain, may be found in Transit’s Geometric Design Manual available on [www.transit.govt.nz](http://www.transit.govt.nz).

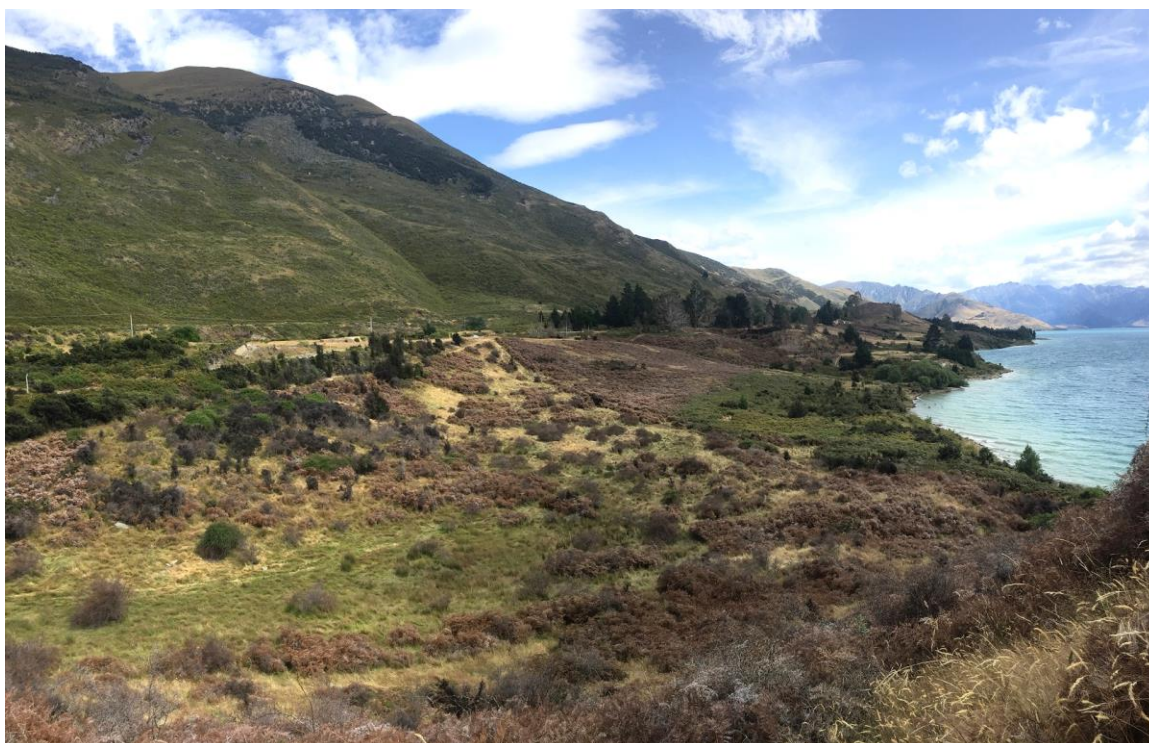
**Photo 1. Site photo looking north from the southern end of the proposed subdivision. Lake Hawea is on the right of image.**

The subdivision area is currently undeveloped and is being farmed with livestock. Vegetation cover comprises pasture, light scrub and scattered pine and eucalyptus trees (refer Photo 1).

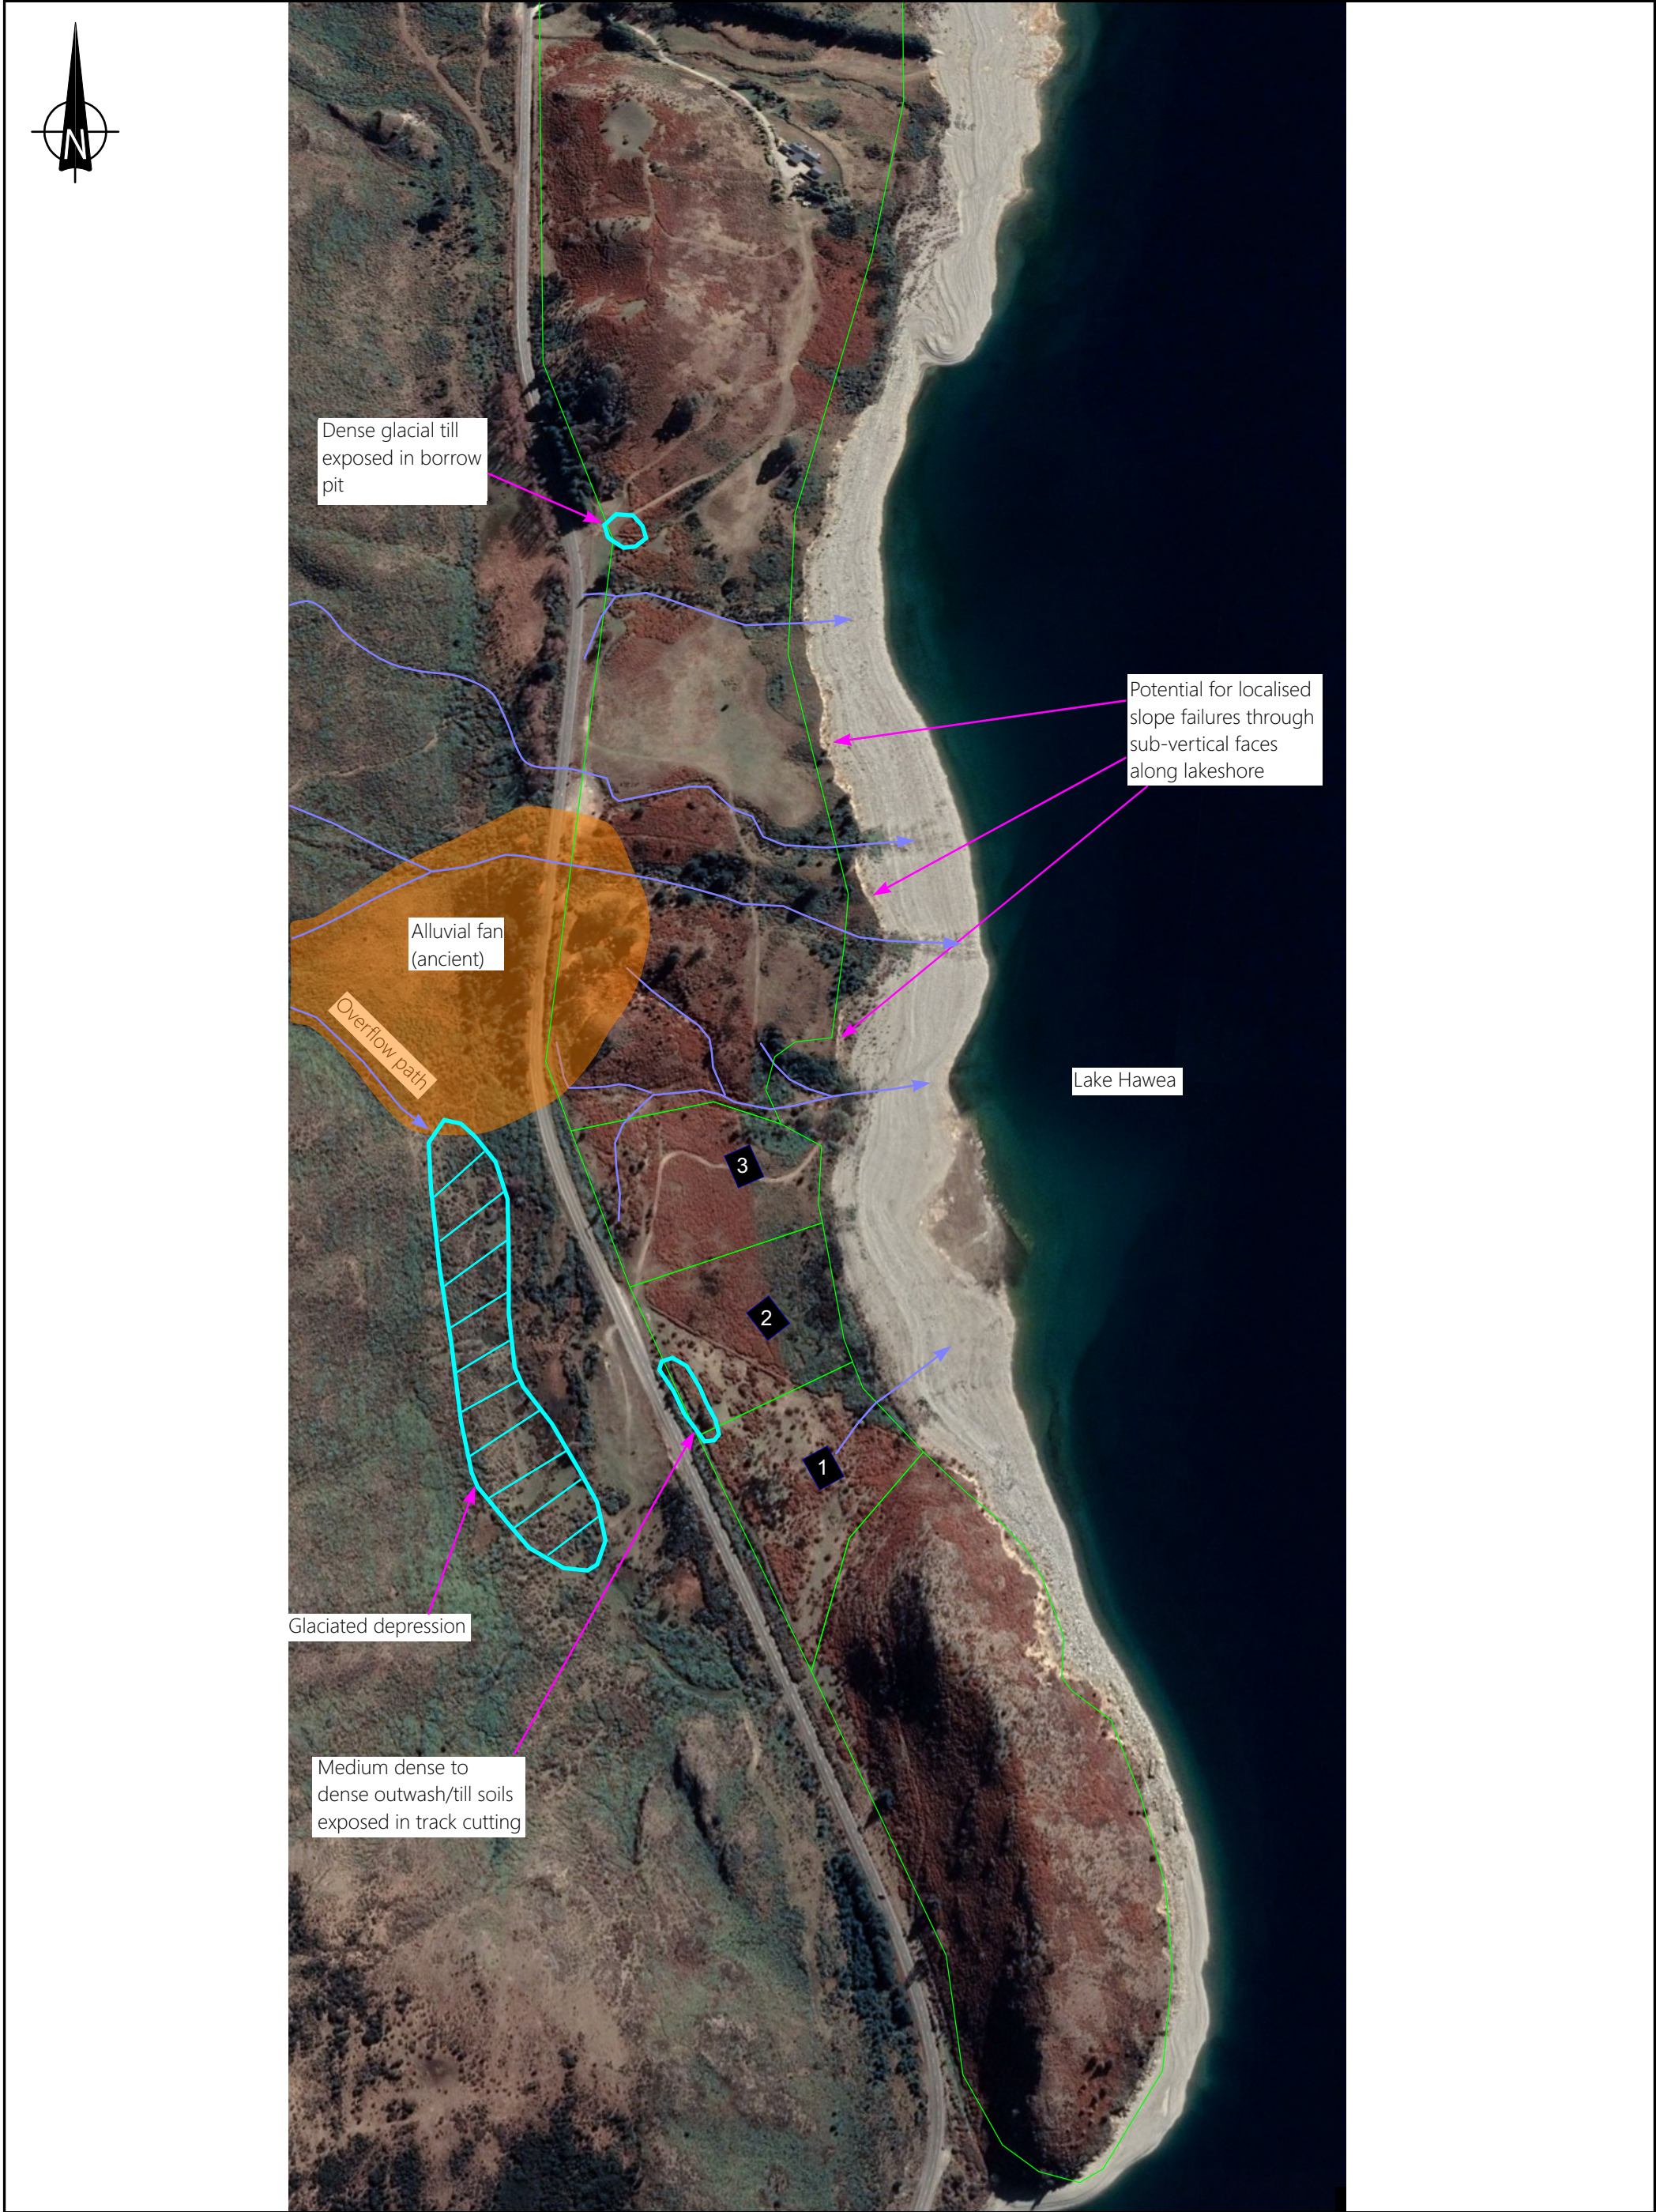
FIG No:  
Appendix A, Figure 1

| <b>Key</b><br><br>→ = Drainage Path<br>— = Subdivision Lot Boundaries | <b>1</b> = Building Platform Locations<br><br>Scale 1:6500<br>0 100 200 300 400(m) | DRAWN | JXH | 12/22 |

The proposed subdivision scheme plan is outlined on Appendix A, Figures 1, 2 & 3.

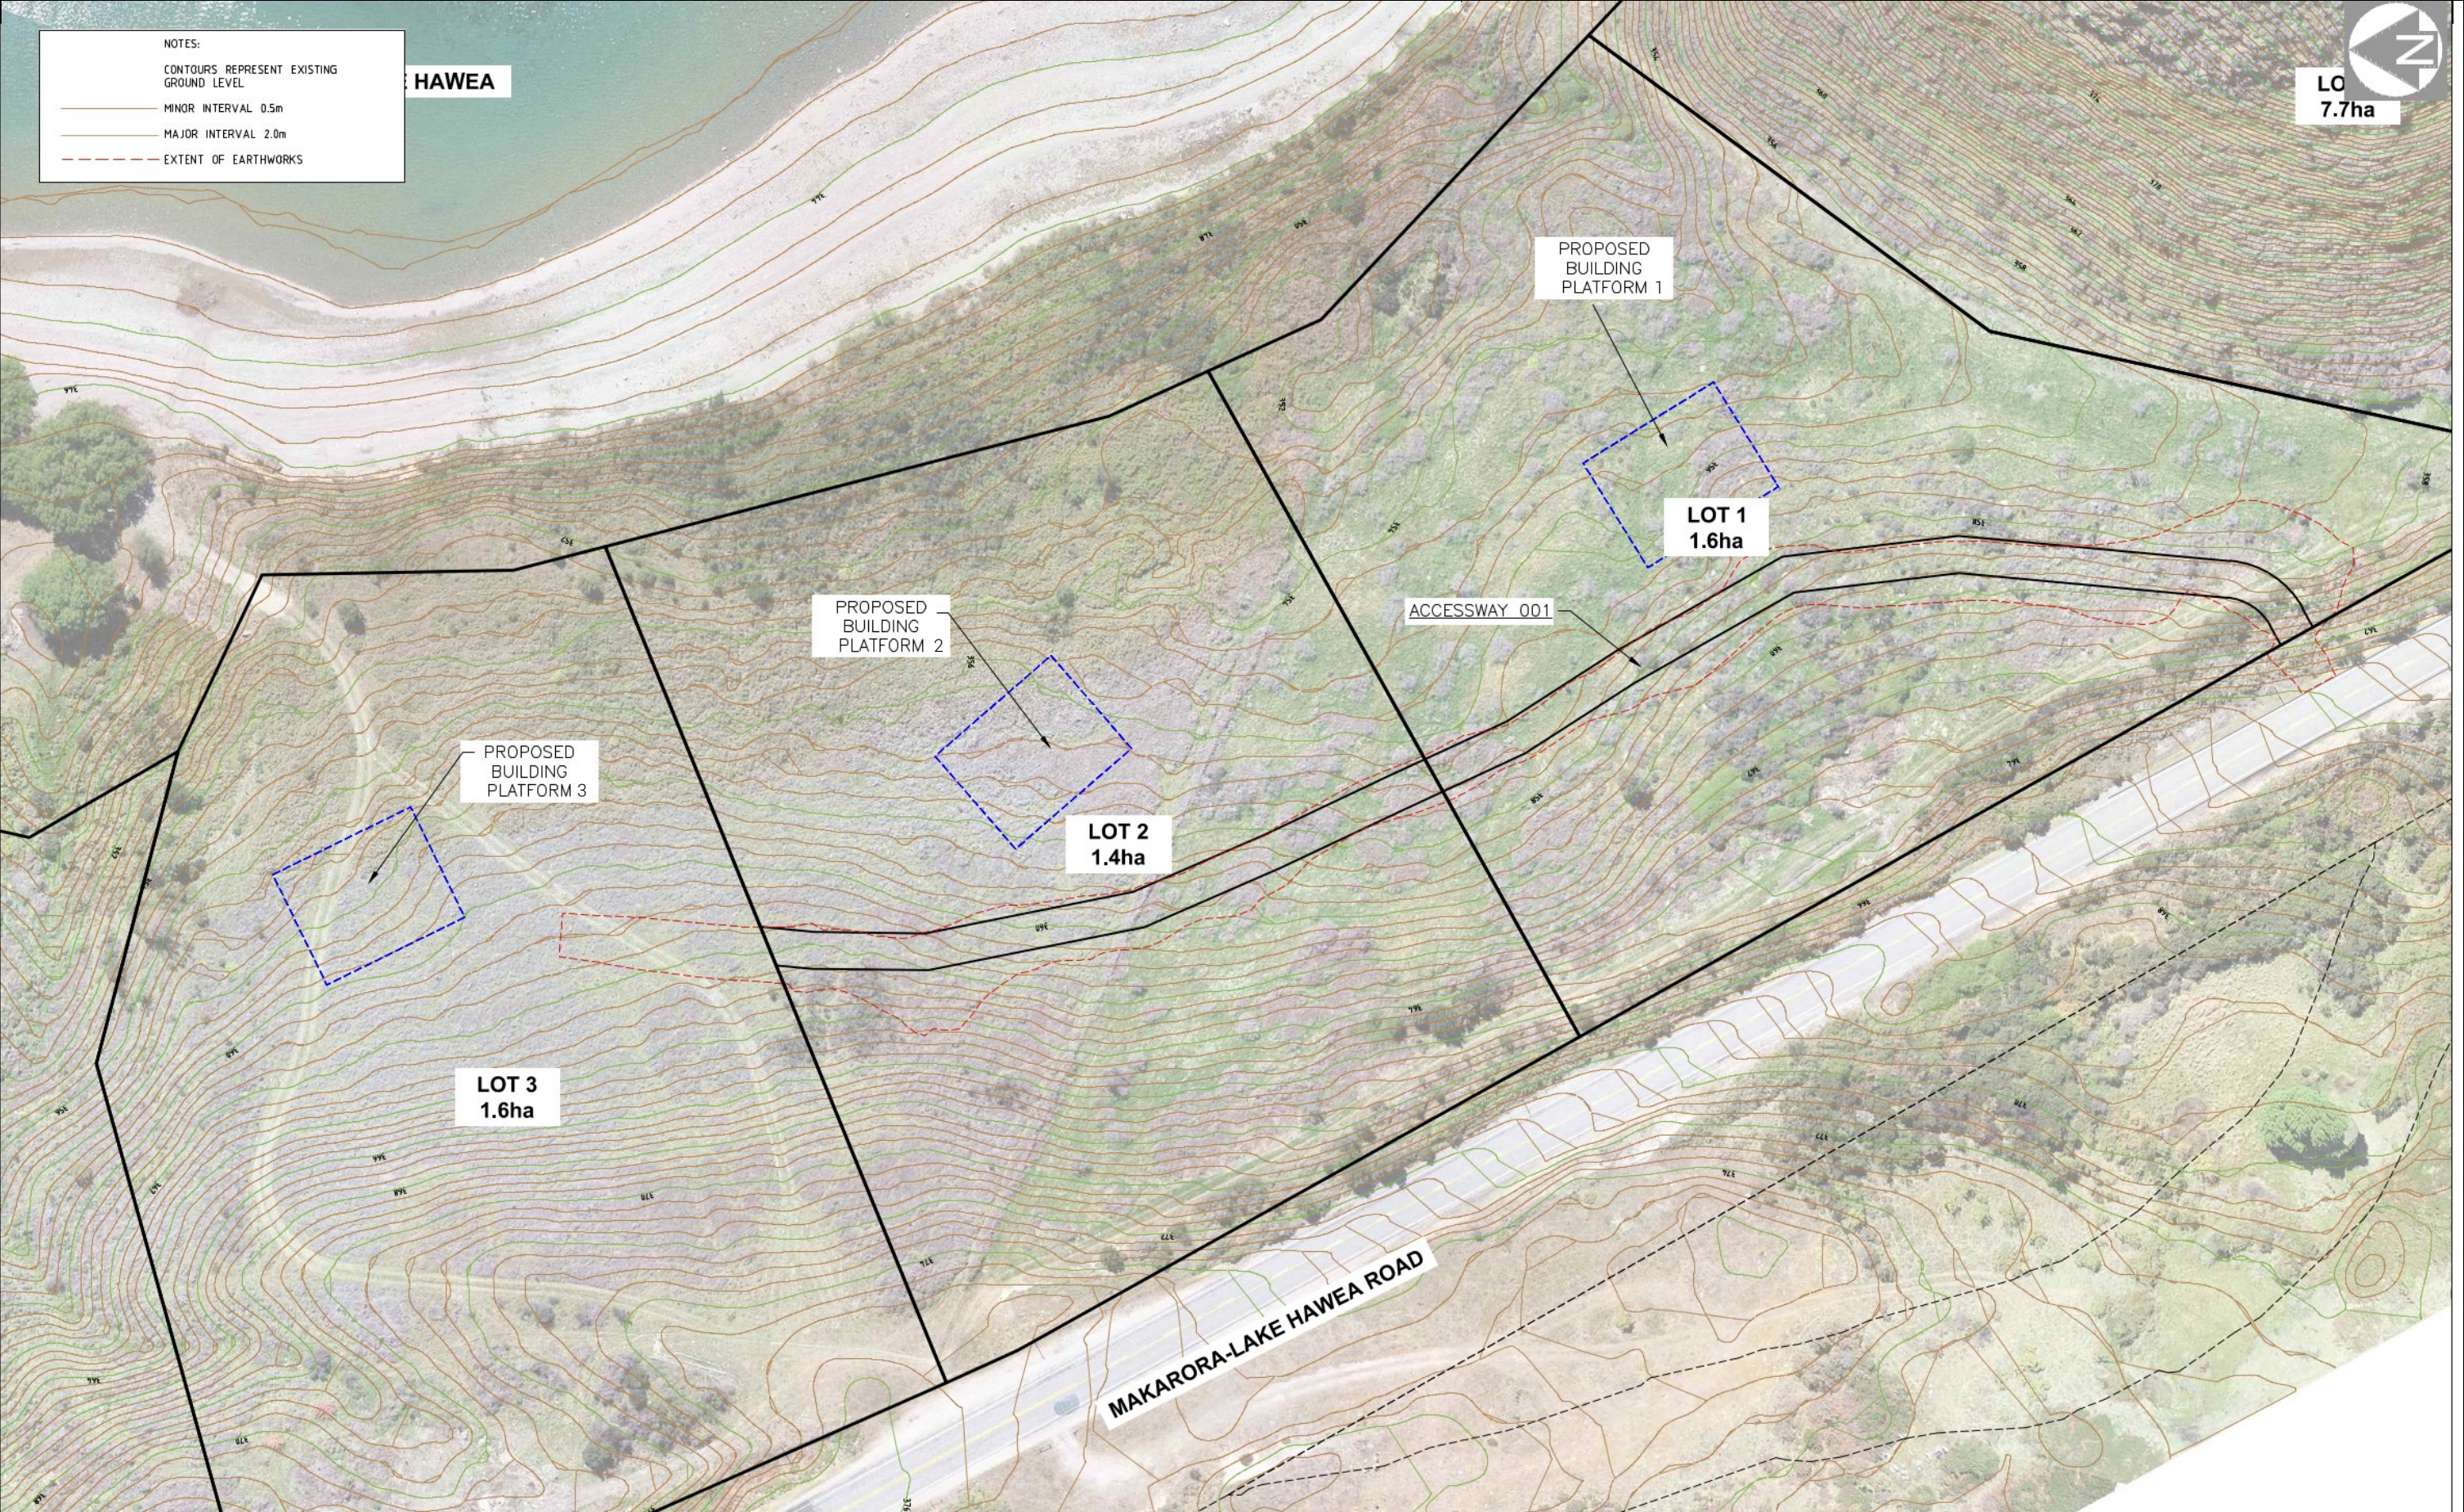
**Key**

= Building Platform Locations

Topographic contour data for the subdivision is presented on Appendix A, Figure 3.

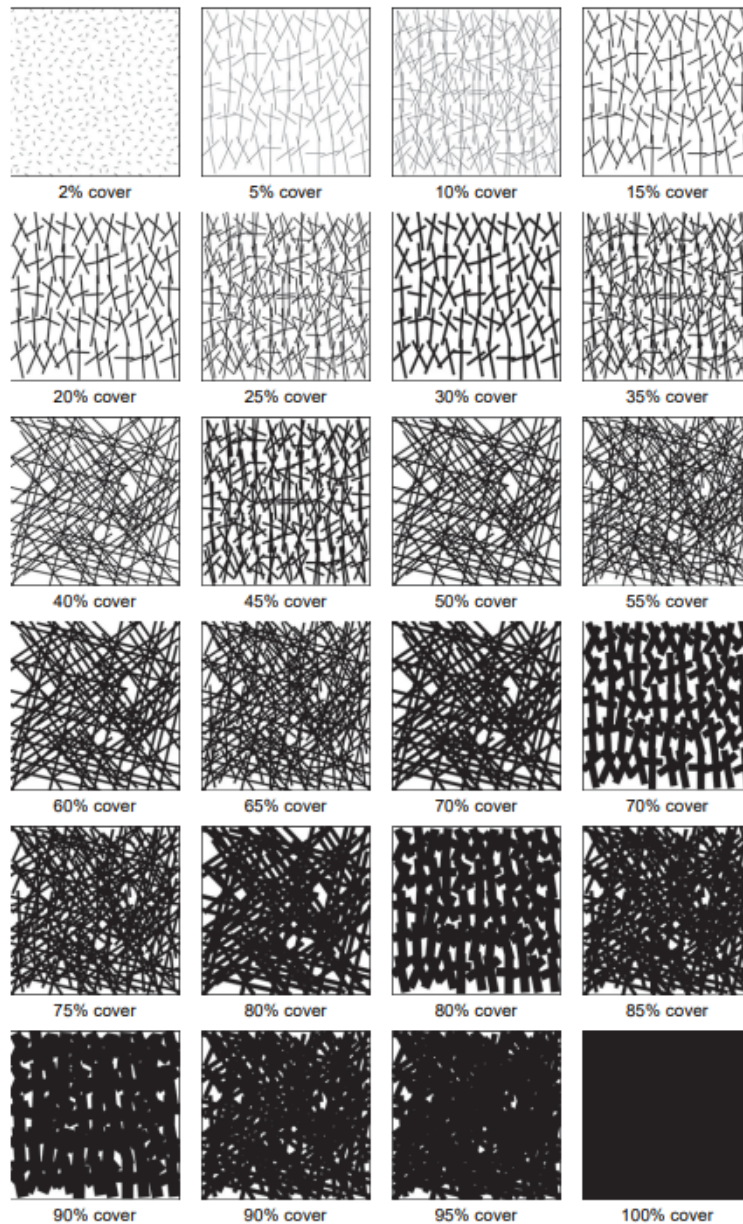
**Figure 2:** Visual cover estimation (Source: Catchments and Creeks Pty Ltd)

Erosion and sediment control devices will remain in place until 'stabilisation' of the site has been achieved. This is generally defined as 80% vegetative cover as depicted in **Figure 2**.

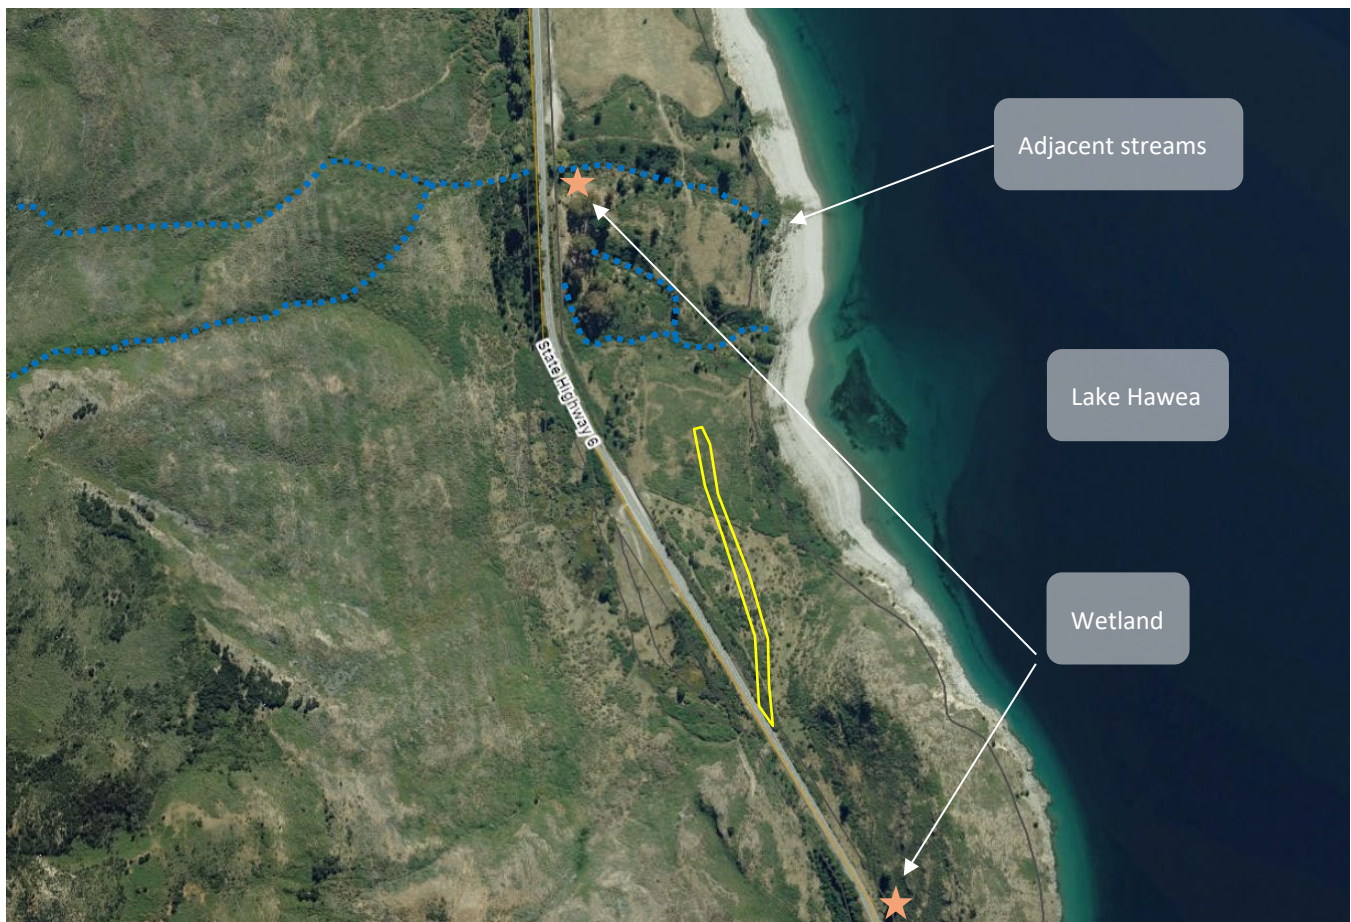
**Figure 3:** Waterways within proximity to the access

An unnamed small stream located to the north of Lot 3 terminates to Lake Hawea, from part of the upslope Mt Maude catchment. This is located some distance outside of the proposed earthworks catchment, as indicated in [Figure 3](#) below.
