LOTS 1 - 5 BEING A PROPOSED SUBDIVISION OF  
LOT 1 DP 396356 - THE DENE, HAWEA  
SITE DETAIL & NATURAL GROUND LEVELS

LOTS 1 - 5 BEING A PROPOSED SUBDIVISION OF  
LOT 1 DP 396356 - THE DENE, HAWEA  
PROPOSED ACCESSWAY LOCATION

# Natural Hazards Assessment

# Environmental Management Plan (Rev A)

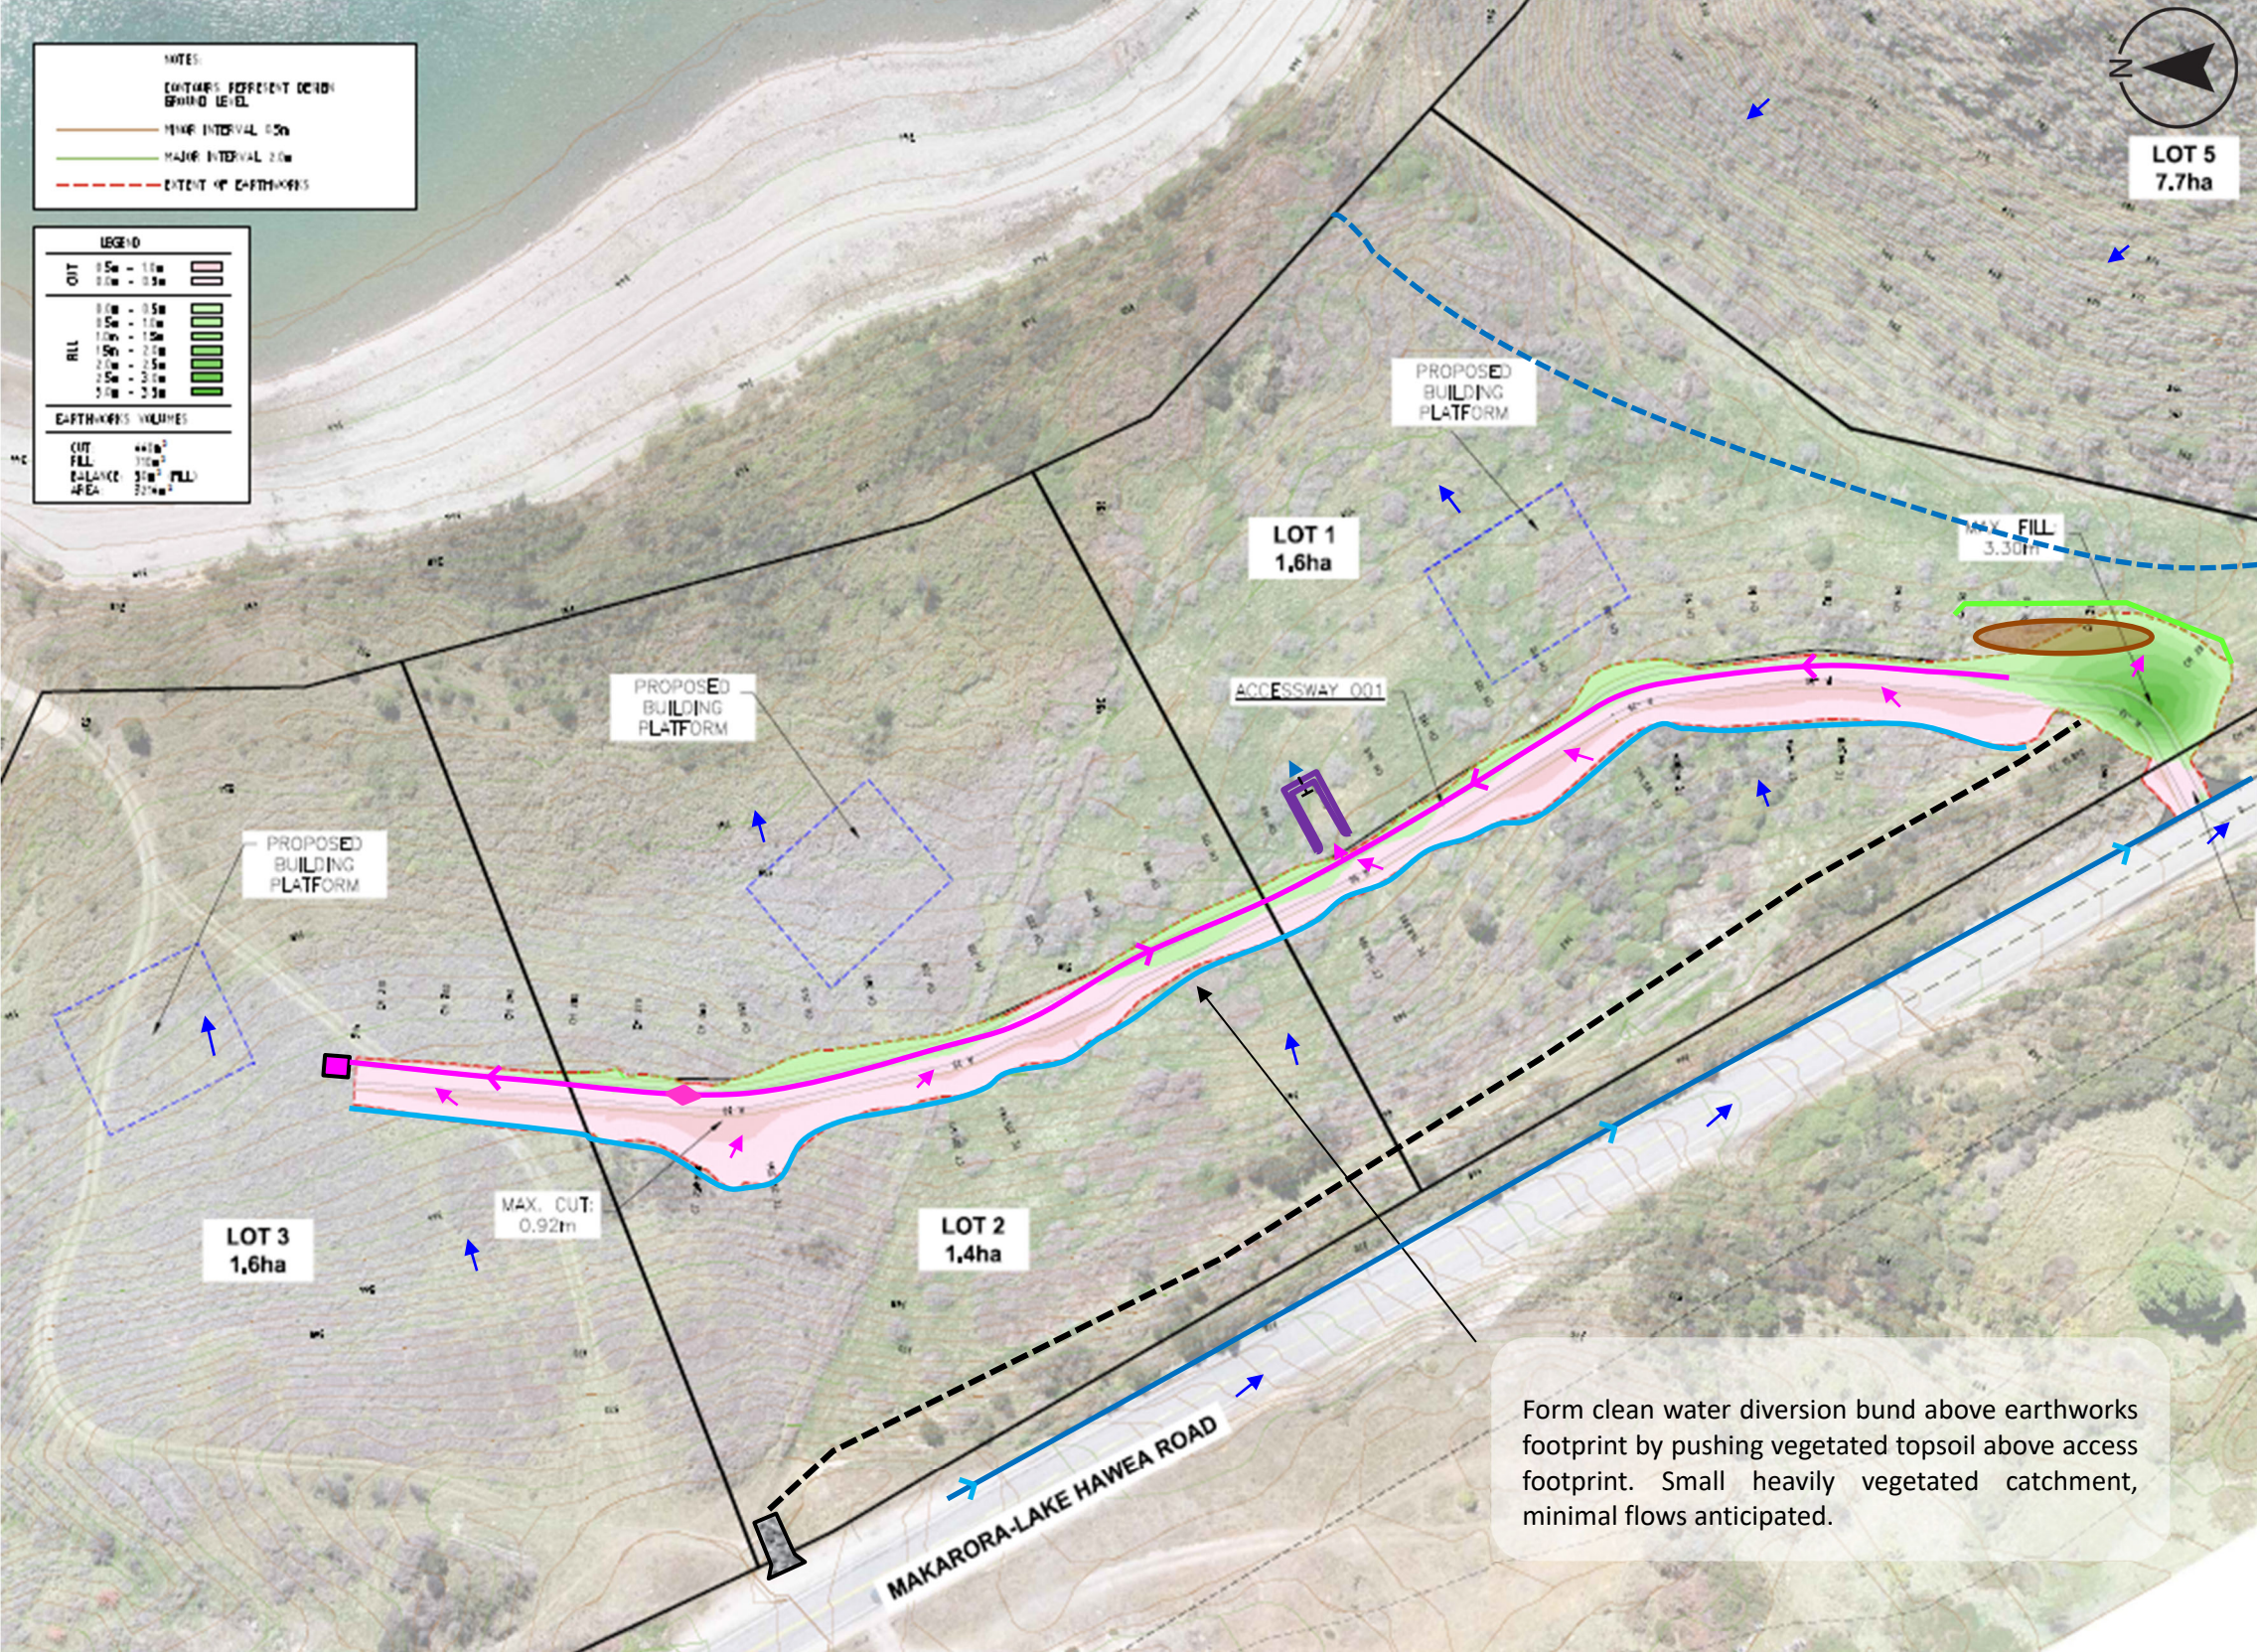
## Erosion and Sediment Control Plan Drawing

Legend

| | Stabilised access |

The following sequencing will ensure the earthworks are undertaken efficiently while ensuring good environmental outcomes. This is a preliminary staging methodology and may be subject to change based on site conditions encountered during construction. This methodology shall be read in conjunction with the Erosion and Sediment Control Plan (ESCP) attached as **Appendix 1**.

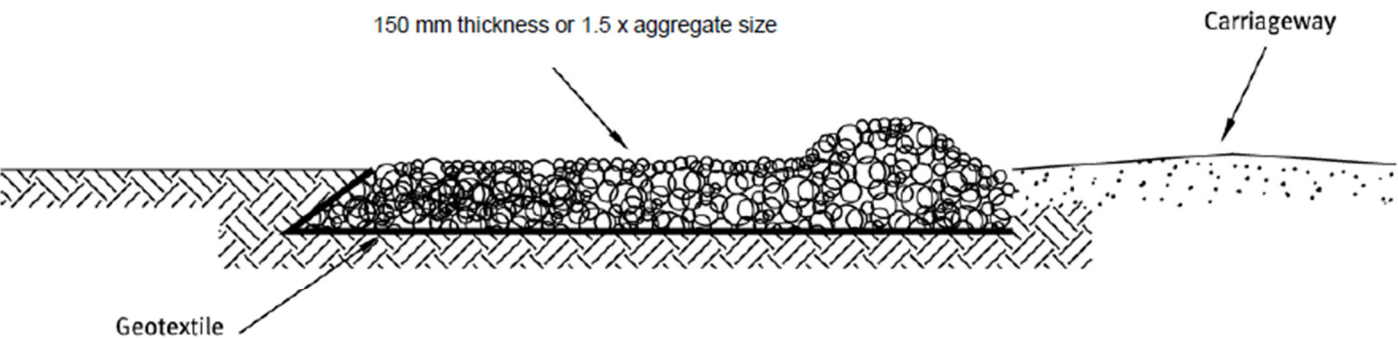
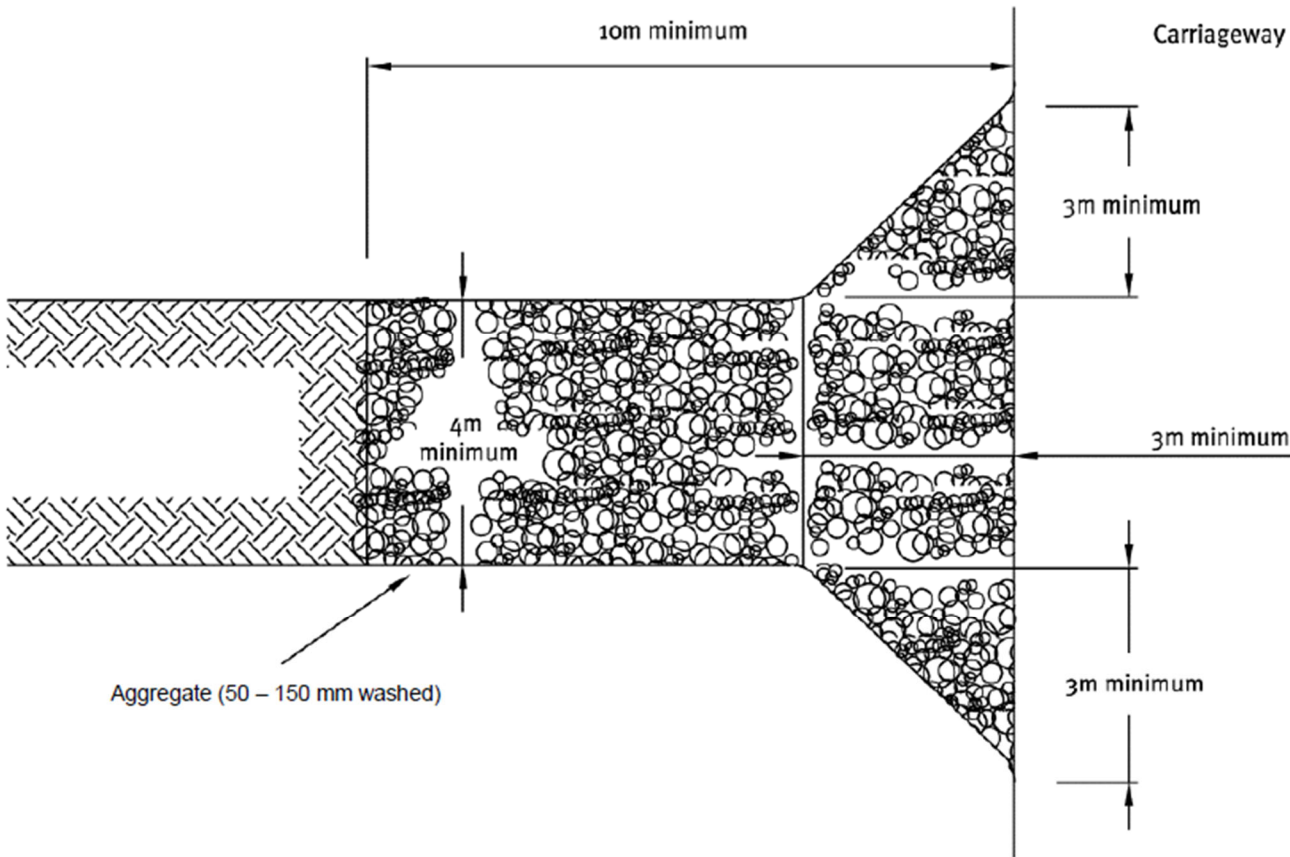
STABILISED ACCESS

Side Elevation

Plan View

- Additional aggregate may need to be added to the stabilised entranceway throughout the project to maintain the thickness.
- Any sediment that has been tracked onto the surrounding roads must be swept away at regular intervals.

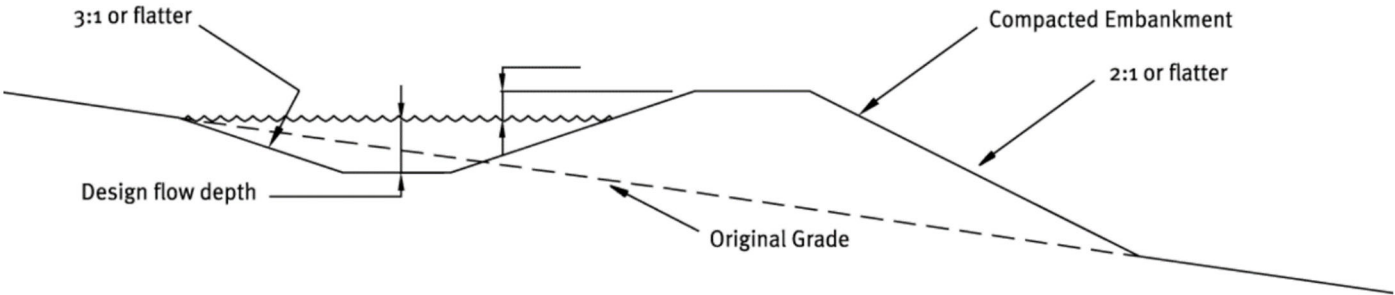
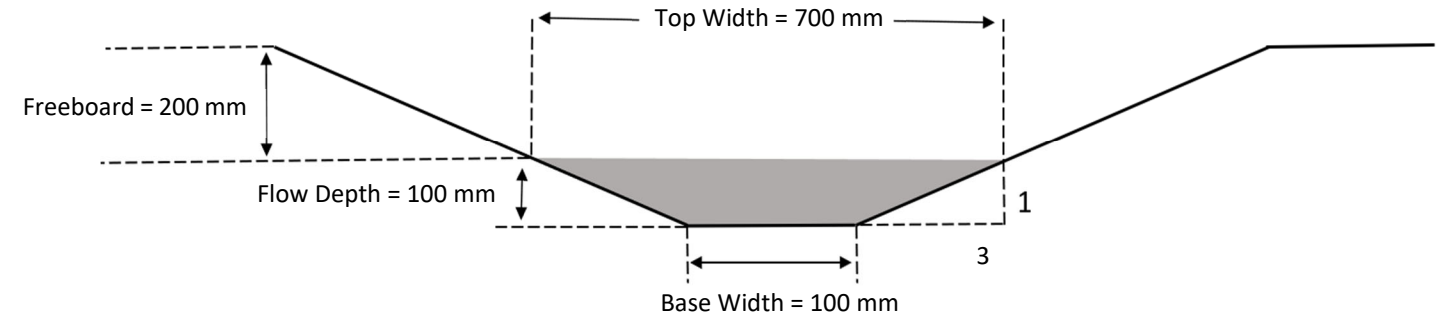
**DIRTY WATER DIVERSION CHANNEL**

**Cross Section**

- This has been designed to convey up to a 5% AEP design event.
- Trapezoidal shape
- Full calculations are included in [Appendix 2](#).

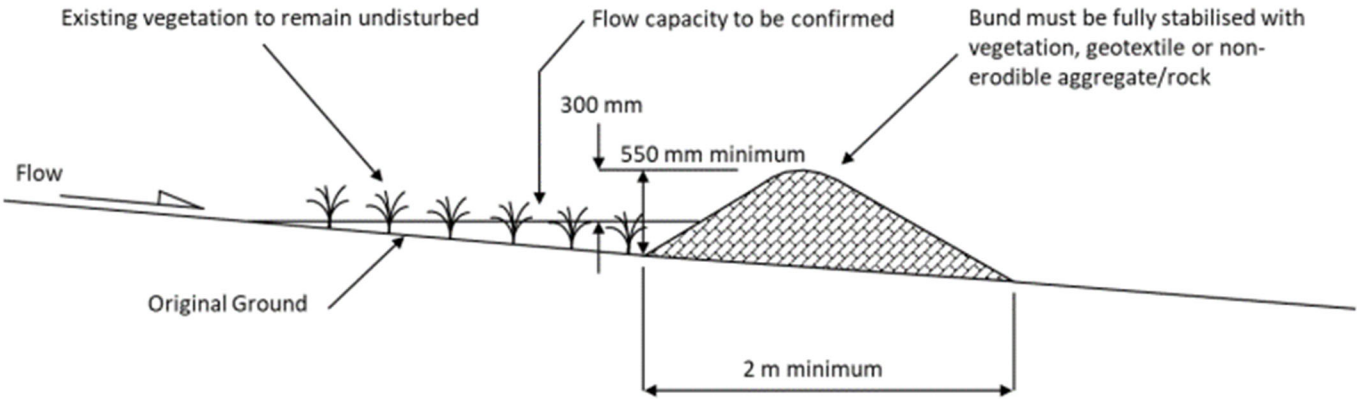
**CLEAN WATER' DIVERSION BUND**

- Ensure bund is well compacted and stabilised.
- Ensure there are no areas of ponding or blockages along the length of the bund.

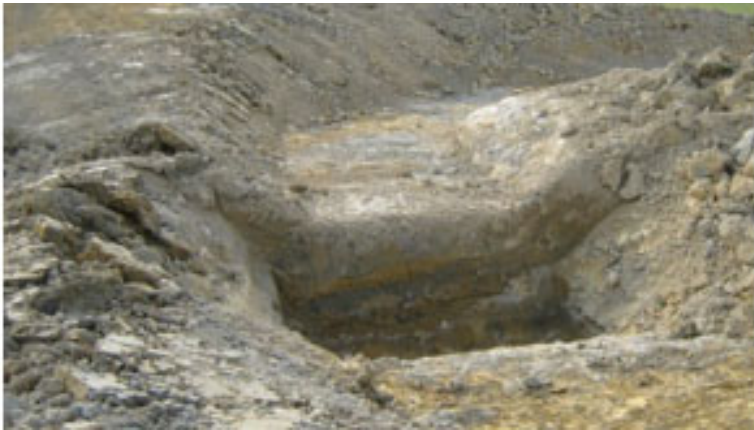
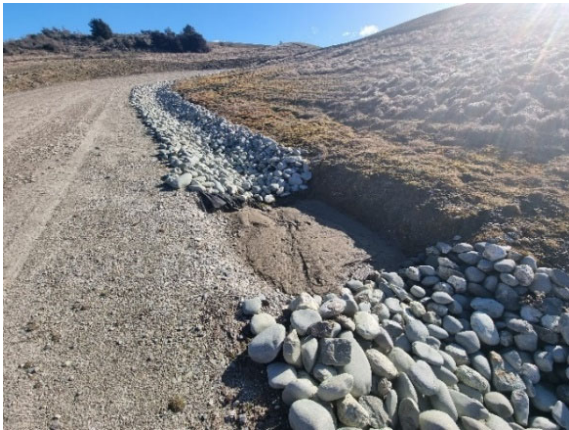
**DROP-OUT PIT**

- Drop out pits should be one metre deep by one-metre-wide cube.
- As a contingency measure, drop out pits can be increased in size and lined to prevent any scour of the pit.

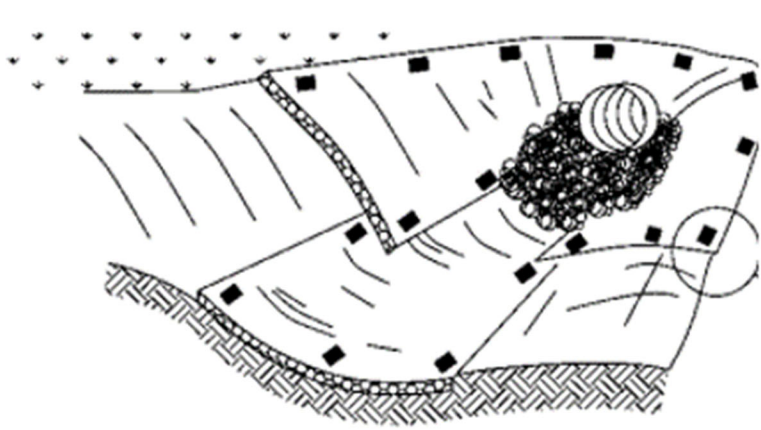
**TEMPORARY CULVERT**

- To be non-perforated concrete, PVC or plastic drainage coil.  
**OR**
- The culvert should consist of a PVC or farm-grade culvert to allow for heavy haul vehicles to traffic over.
- Geofabric and rock should be placed at the outlet to prevent scour from the higher velocity water exiting the culvert.

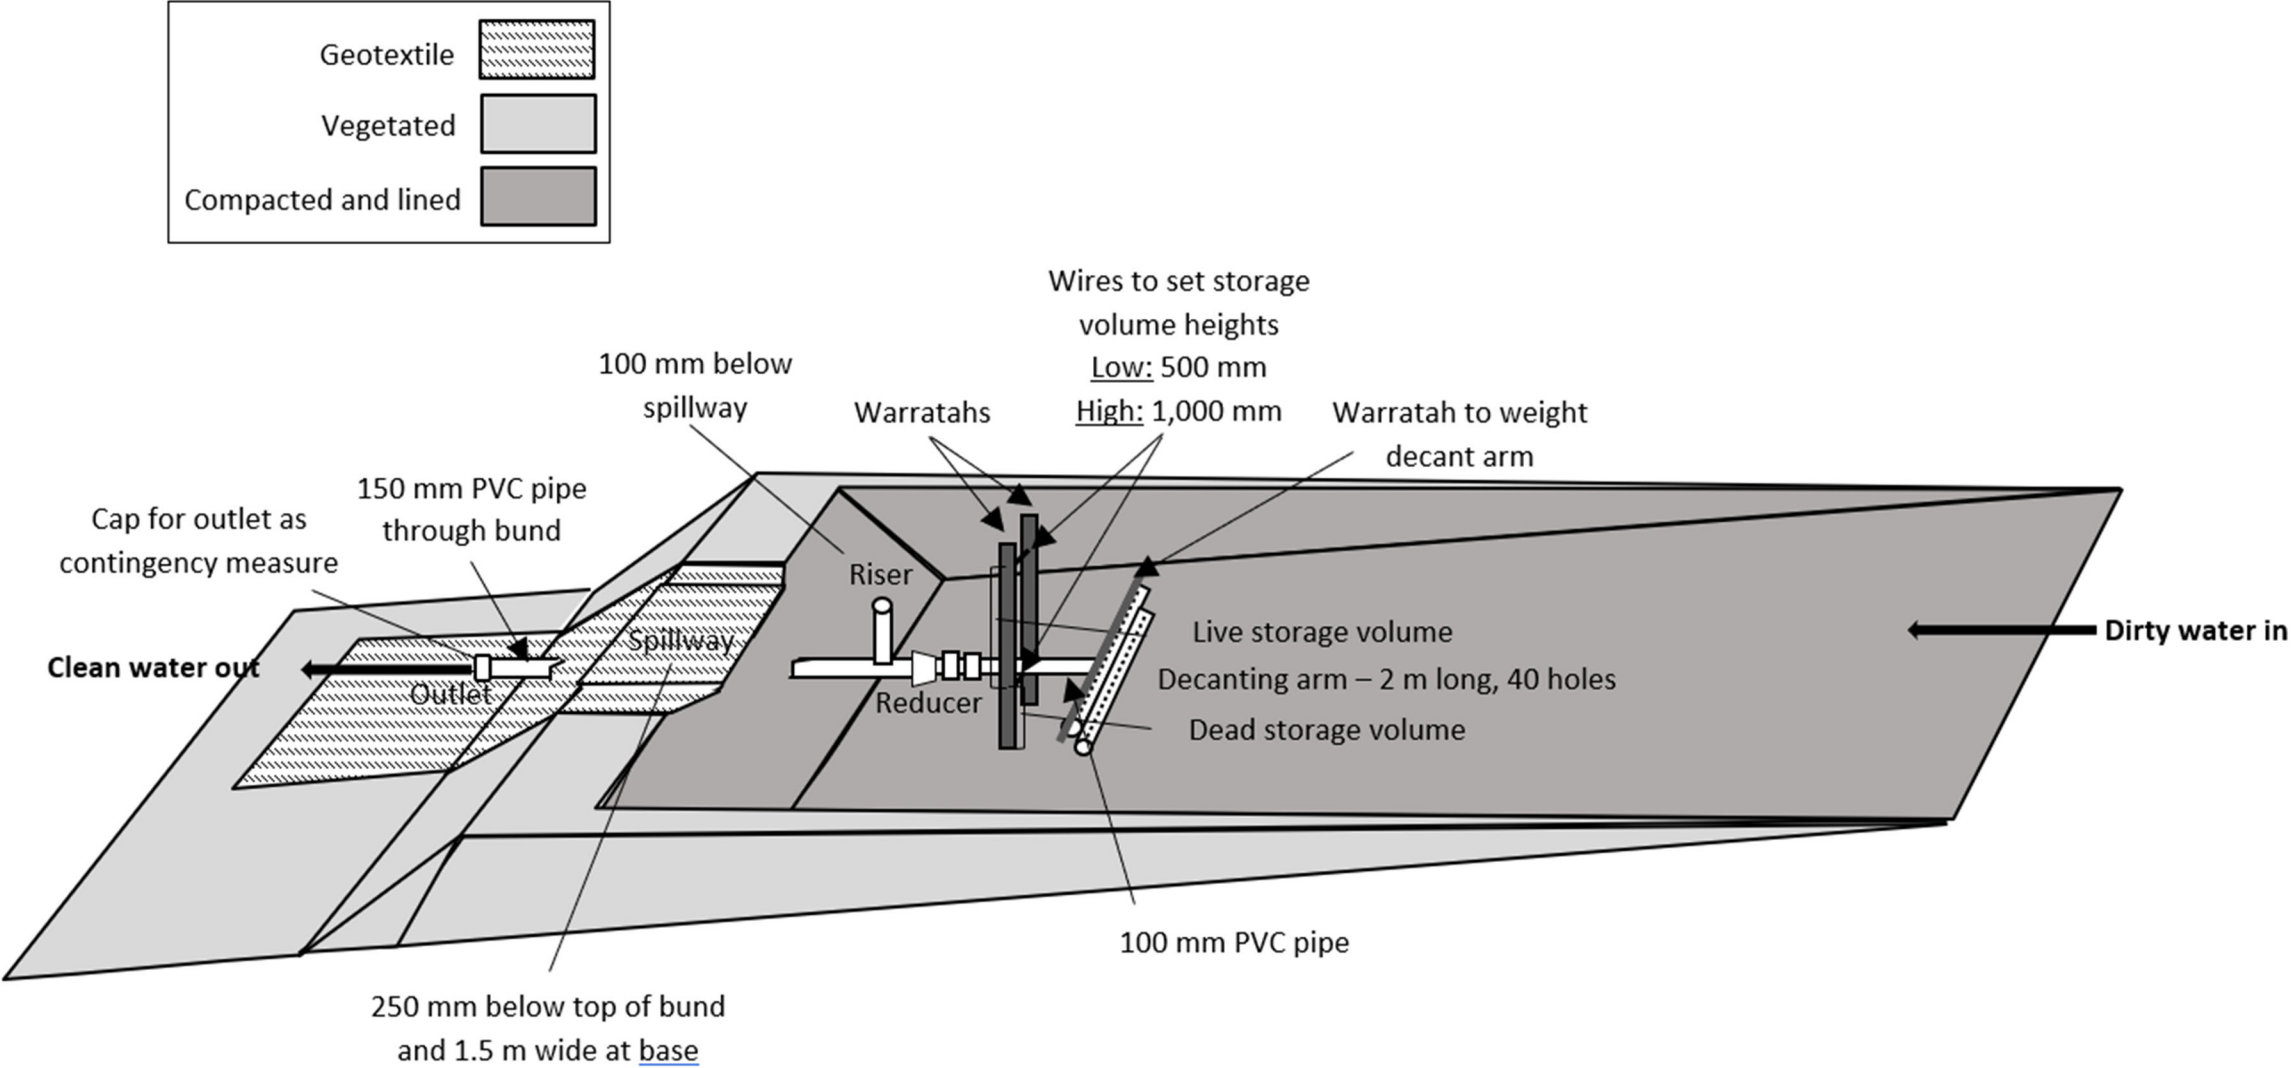
**DECANTING EARTH BUND**  
Page 106-112 from GD05

- See [Appendix 2](#) for full calculations.

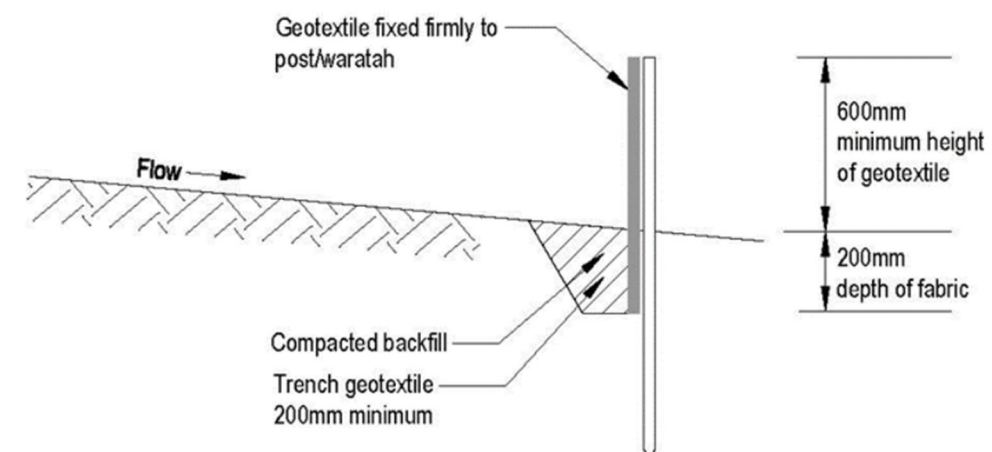
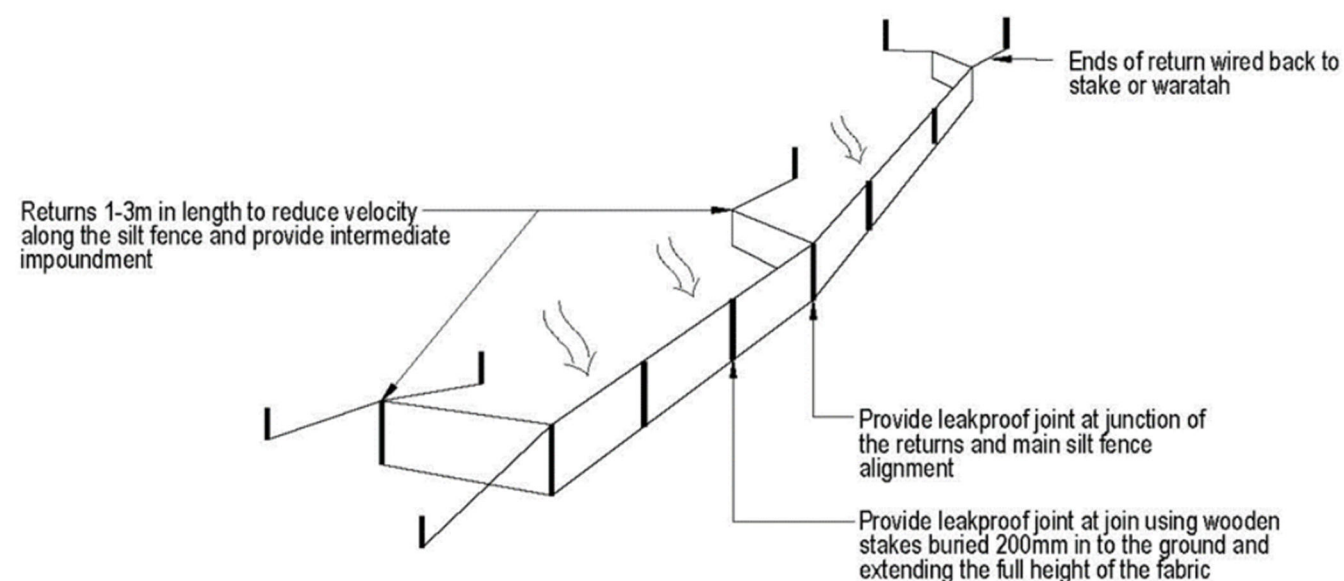
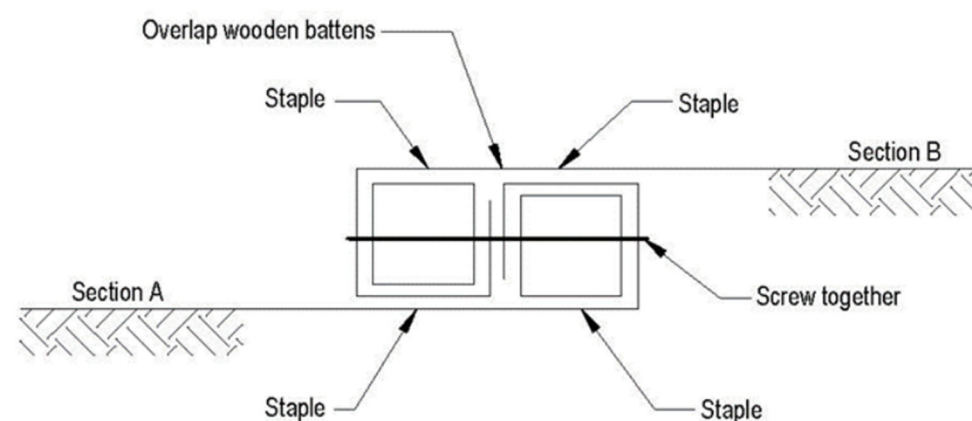
## STANDARD SILT FENCE

| Slope steepness (%) | Slope length (m)<br>(maximum) | Spacing of returns (m) | Silt fence length (m)<br>(maximum) |

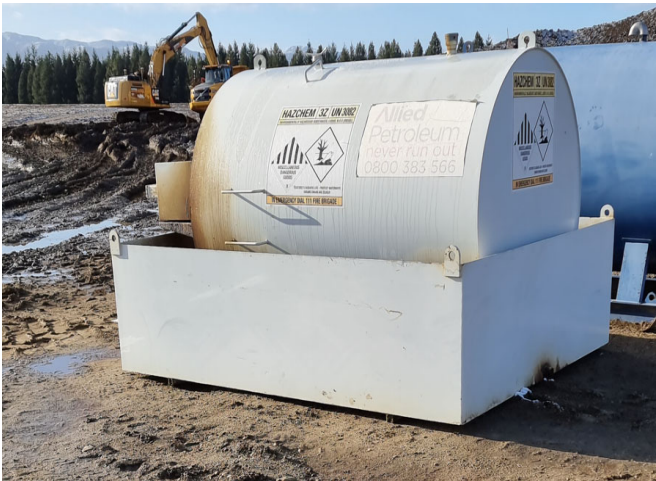
REFUELING BAY

- Locate the hardstand as far as practicably possible from waterways and concentrated flows.
- Ensure spill kit is located nearby.

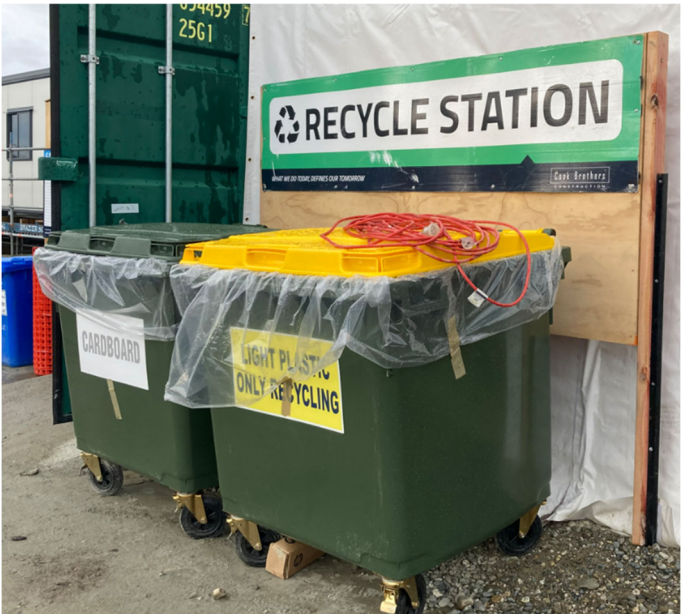
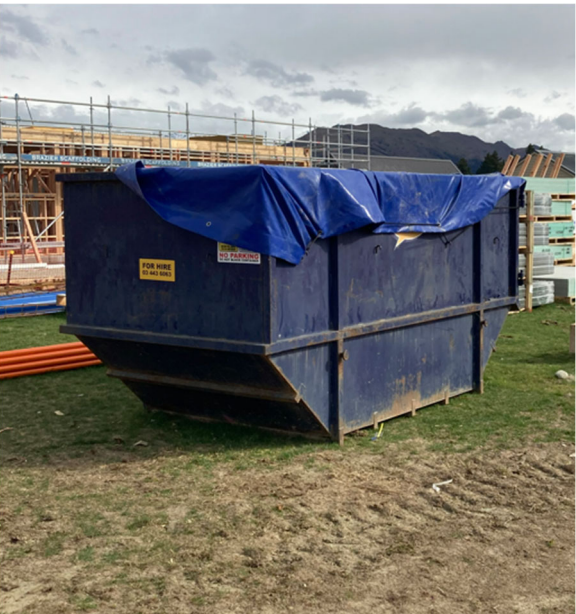
WASTE

- Where possible, waste shall be segregated into labelled bins.
- Wastes on site will be suitably contained and prevented from escaping off site. This may include covering skip bins during high winds.
- Waste storage is not permitted in or near drainage paths.
- Wastes will be removed from site when bin is full.

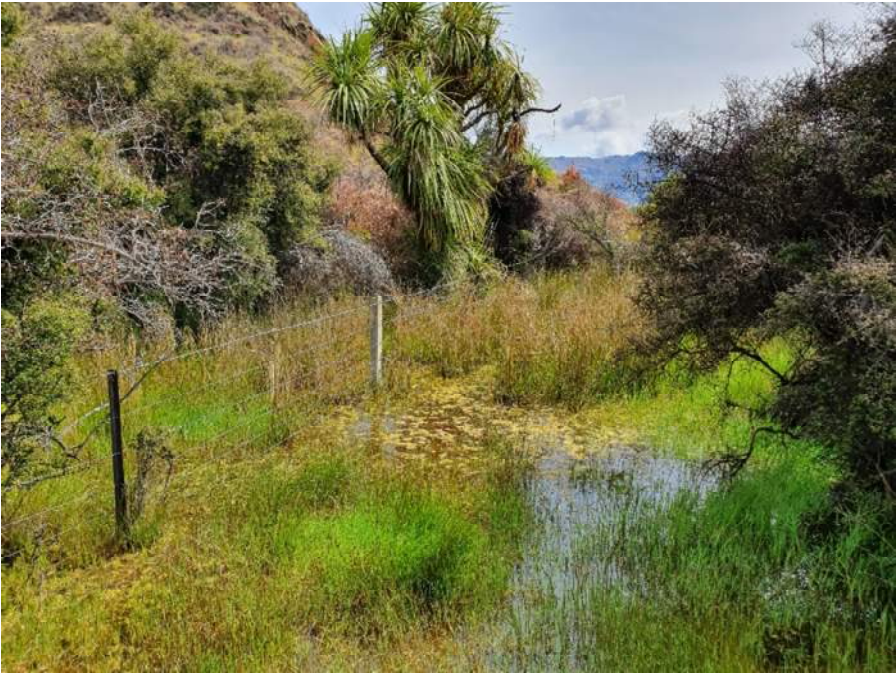
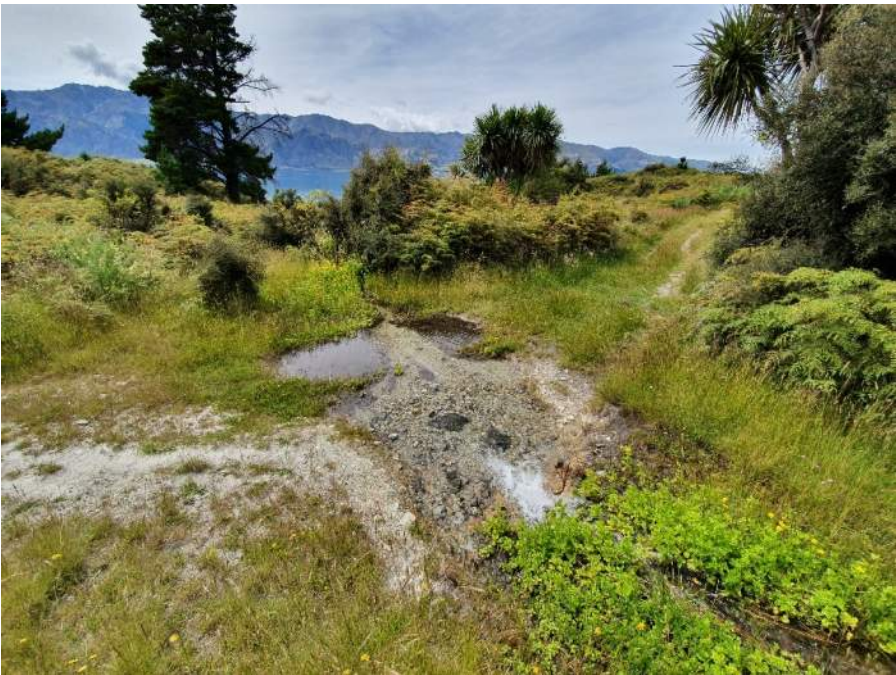
| Photo No. | Date | |
|---|---|---|
| 3 | 8 January 2020 | |

| Photo No. | Date | |
|---|---|---|
| <b>Description</b><br>Surface water present on site. | | |

| Photo No. | Date | |
|---|---|---|
| <b>Description</b><br>Surface water present on site. | | |

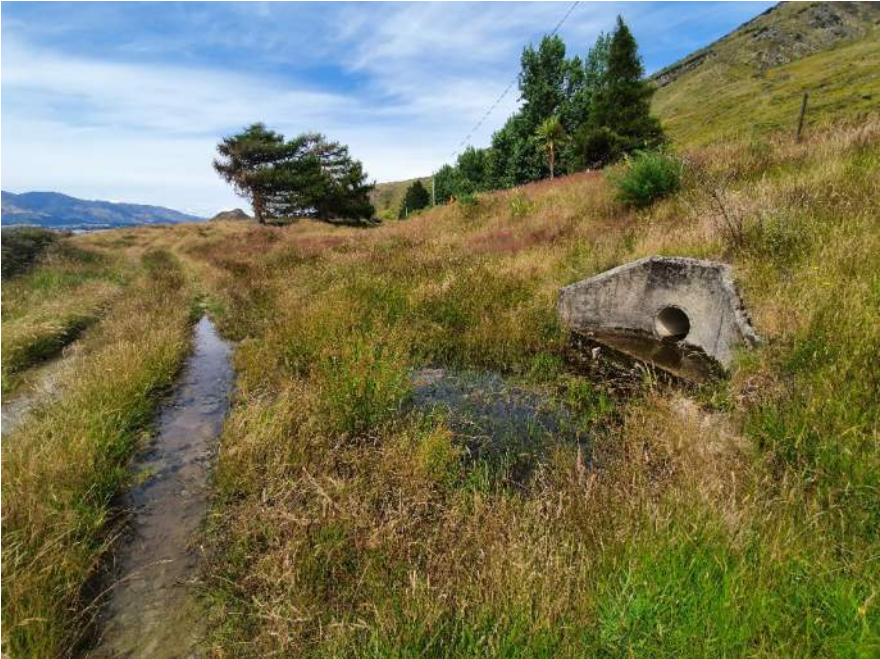
| Photo No. | Date | |
|---|---|---|
| 6 | 8 January 2020 | |

| Photo No. | Date | |
|---|---|---|
| <b>Description</b><br>Storm water outlet.<br><br>Photo taken facing south. | | |
