# **Natural Hazards at Makarora**

**April 2007**

**Otago Regional Council  
Private Bag 1954  
70 Stafford Street  
Dunedin**

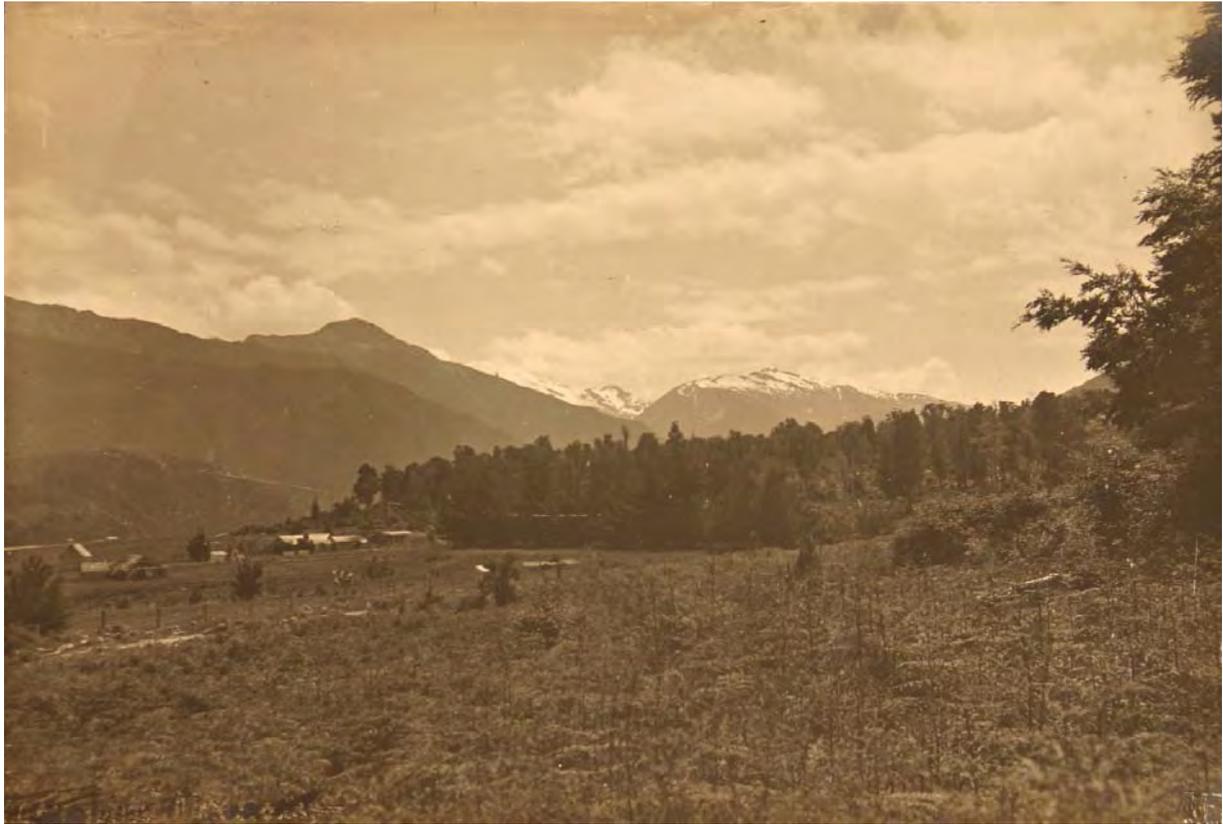
Figure 4: Makarora Township and forest on the Pipson Creek alluvial fan, early 20<sup>th</sup> century (1902?).

The known events that may have affected forest growth on Pipson Creek alluvial fan are Hassing’s burning of the valley floor and logging in the years following 1861. However, early photographs of the Pipson Creek alluvial fan show that the forest survived at least until the early twentieth century (Figure 4) and the forest present today is substantially similar (Figure 5). Earthquakes on the Alpine Fault (Figure 7) may also have caused sediment inputs to the alluvial fan from seismic-induced mass movement in the catchment.

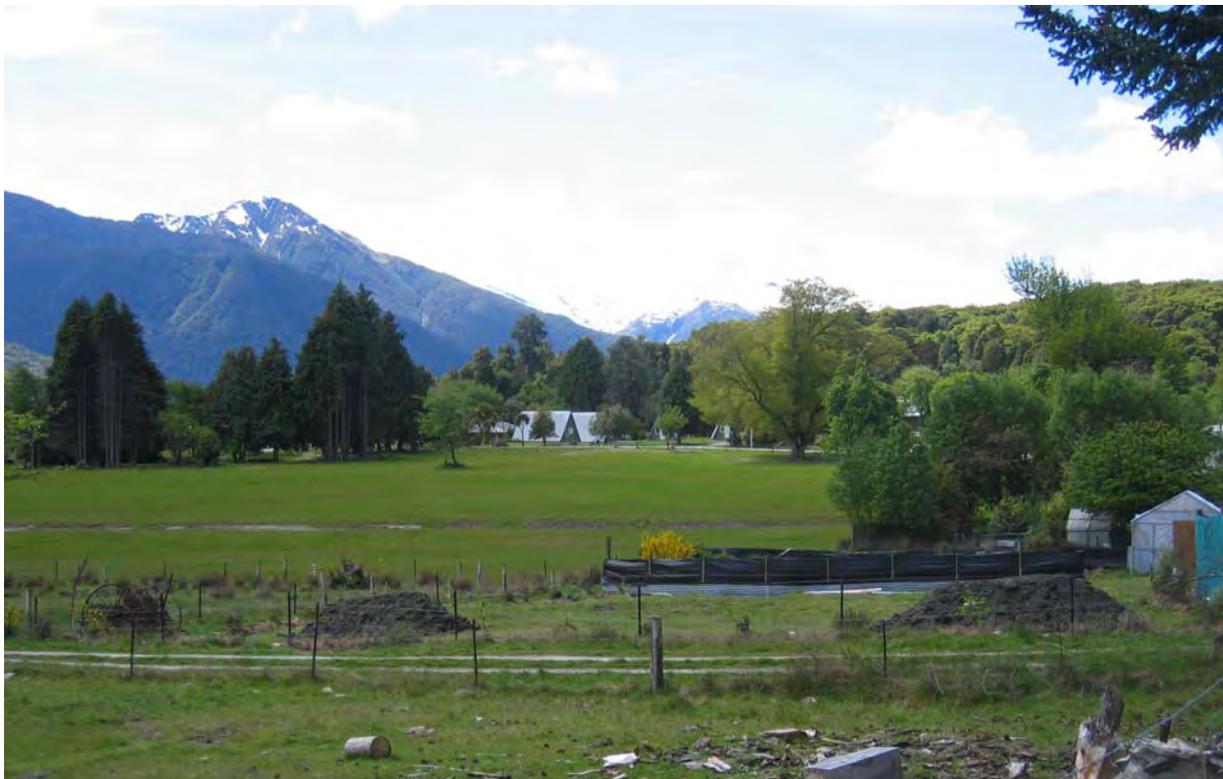
Figure 5: Substantially the same view as Figure 4, October 2006.

Further later impacts from logging and additional fires resulted in the almost entirely tree-free lower valley seen today. Hassing’s fire did not remove all forest in the valley, because “[t]he upper Makarora valley was afforested down the fans on the valley floor. Saw milling commenced in 1861, when pit sawing began and subsequently three sawmills operated in the valley. The deafforestation (sic) was severe until around 1900 and has subsequently been almost completed through fire, particularly along the eastern slopes” (Ritchie, 1976). However, in the early part of the twentieth century, the forest on Pipson Creek’s alluvial fan was still extant (Figure 4) and it has probably survived through to today without significant further modification (Figure 5).
