QUEENSTOWN-LAKES DISTRICT FLOODPLAIN REPORT

Otago Regional Council

November 1999

**Report prepared by
Neil Johnstone
Investigations Engineer**

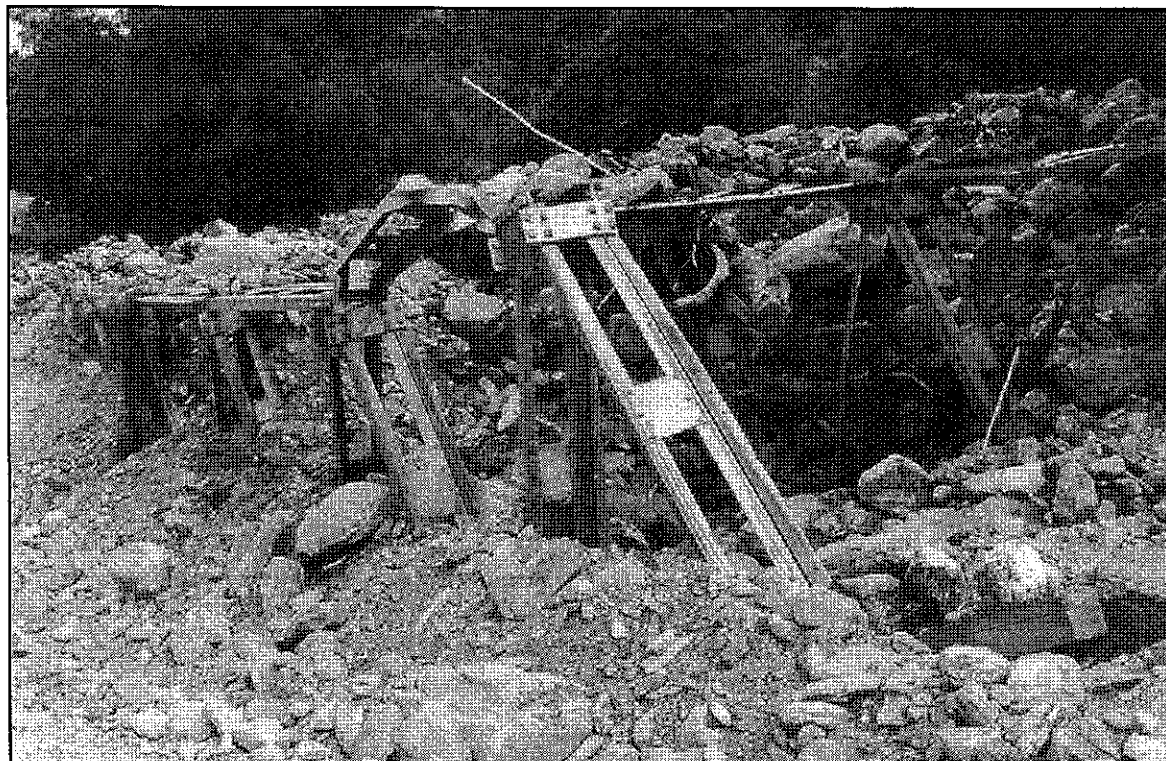
Photograph 2
Wreckage of Kowhai Creek Road Bridge Caused by January 1994 Flood

Tributary creeks such as the Glacier Burn, Turner, Kowhai and Scotts Creeks, that traverse the steep slopes of the Humboldt Mountains can deposit significant quantities of unwanted detritus when they outflank their banks. They also have frequently severed the road links to Kinloch and the Routeburn. In January 1994 the road was severely washed out at Kowhai and Scotts Creeks (see **Photograph 2**).

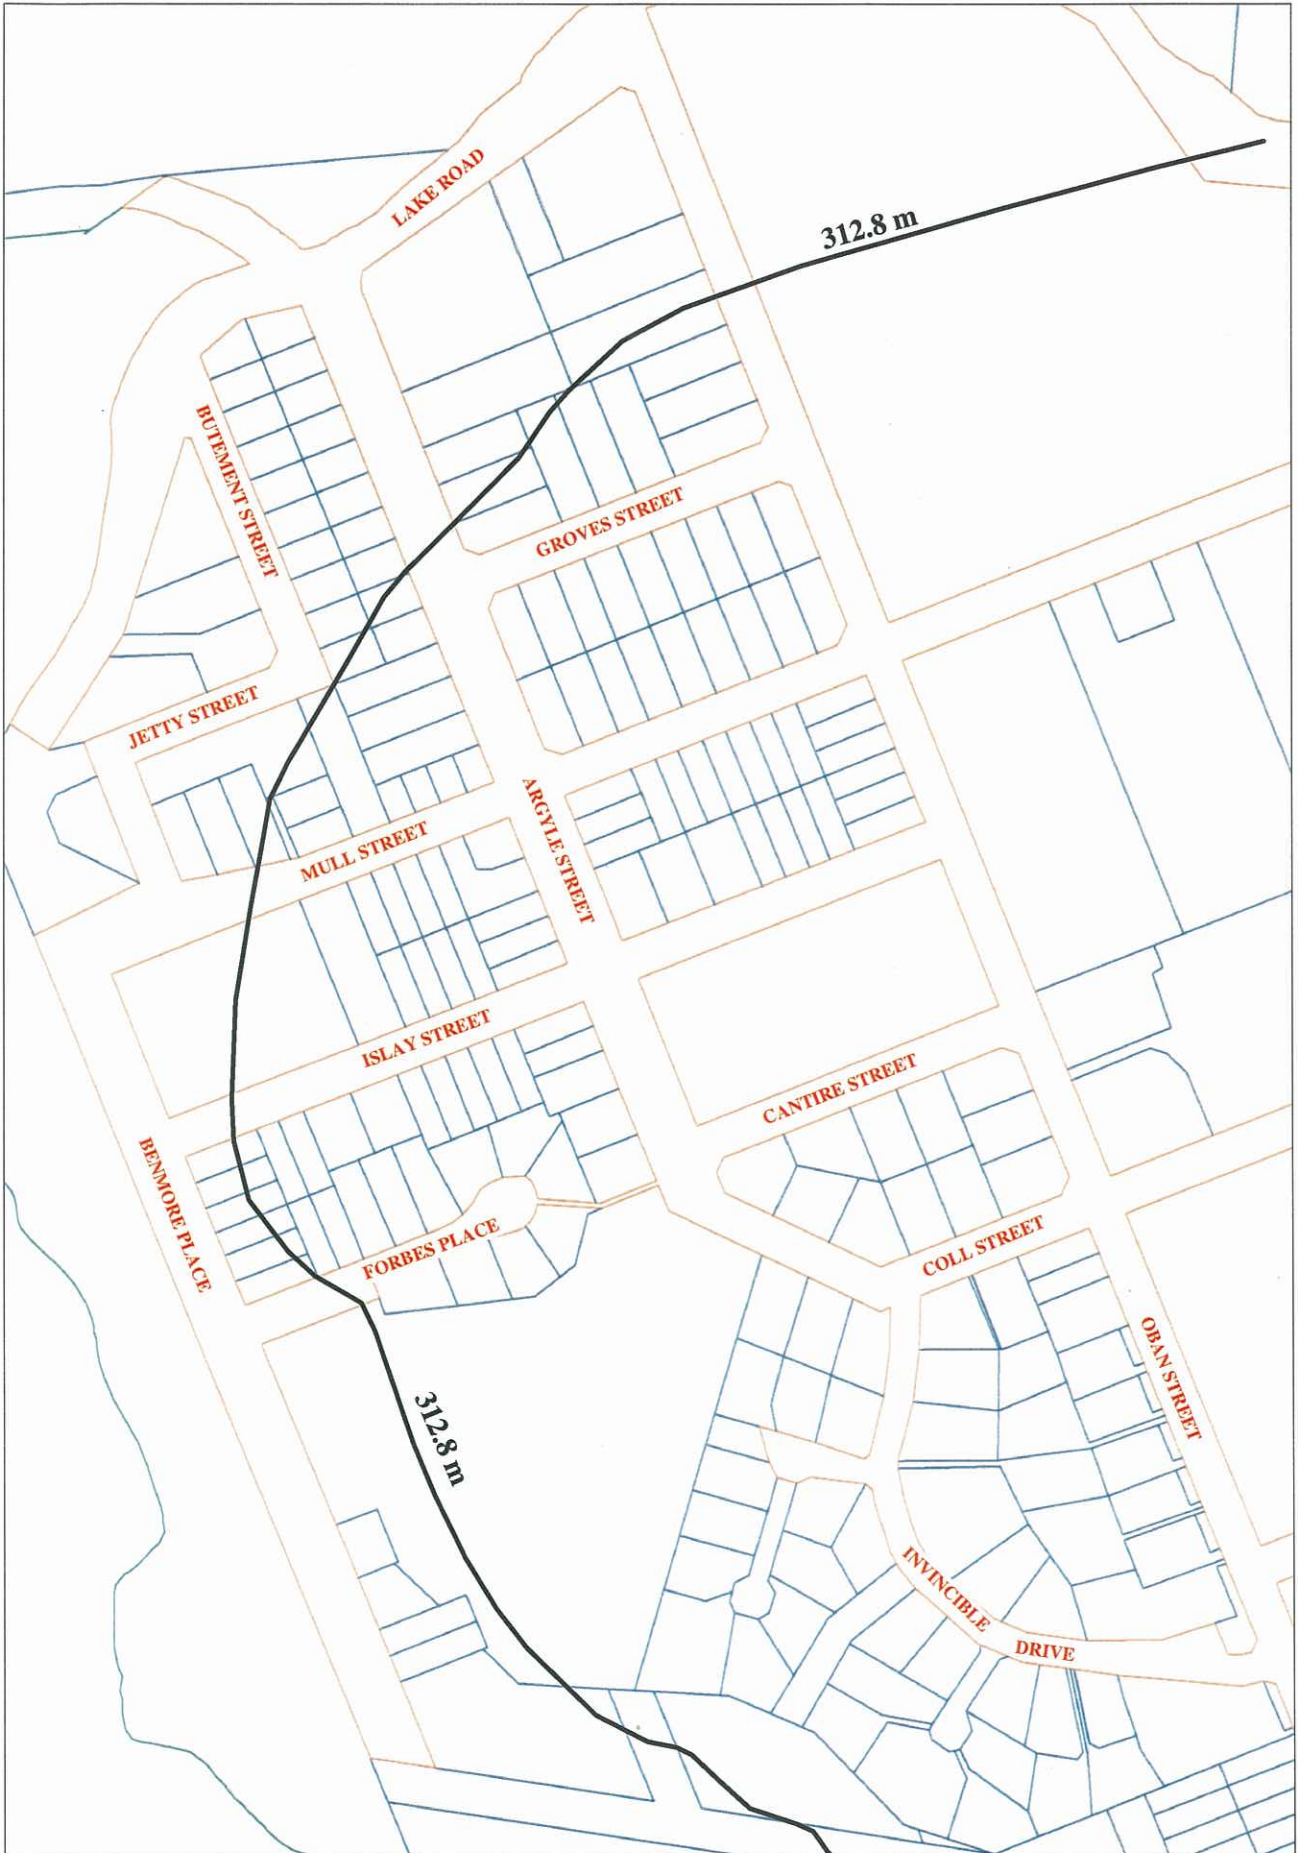
Figure 5
Likely Extent of 1878 Flood Level in Lake Wakatipu at Glenorchy

In recent years minimum floor levels for new buildings in Glenorchy have been set at RL 312.8m. This level is presumed to be the approximate peak water level experienced there in the 1878 flood, with some allowance for Rees River backwater effects. The current proposed District Scheme reduces the building level for Glenorchy to RL 312.0m (the same as Queenstown). The flood hazard zone encompassed by the 312.8m contour at Glenorchy is shown in **Figure 5**.

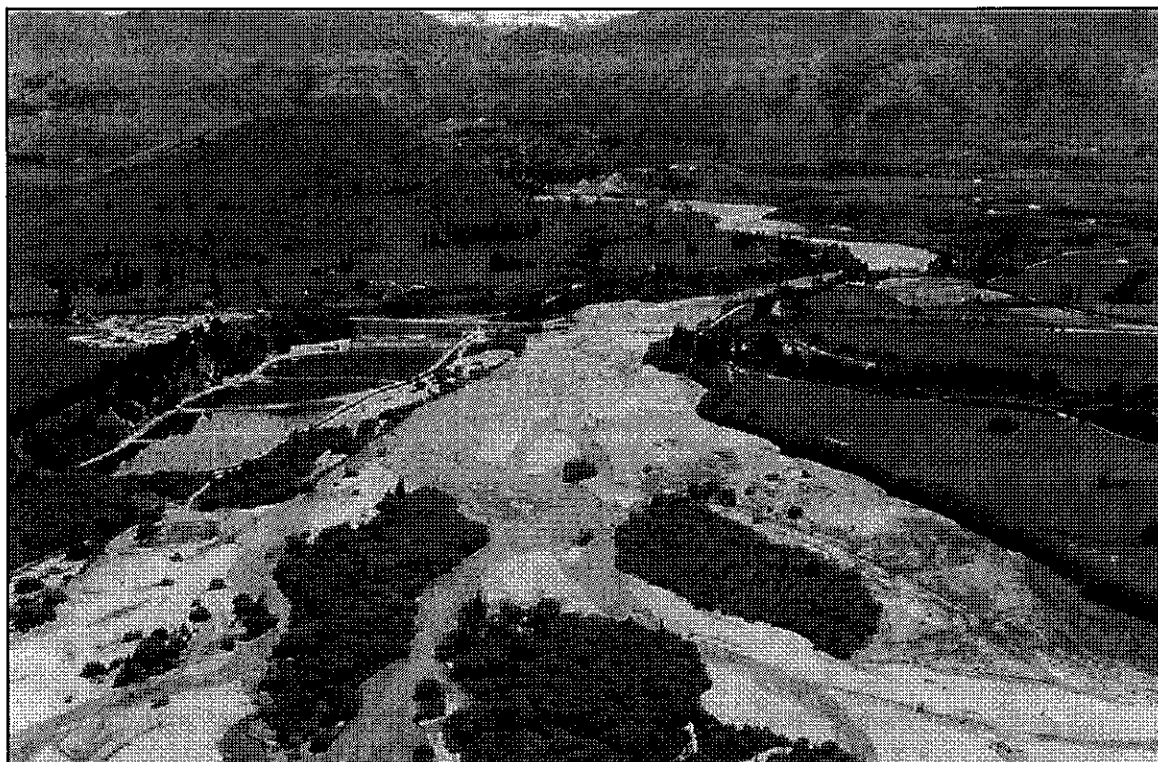
Photograph 6
Shotover River Delta (November 1994)

Unlike the other major high country rivers, the Shotover discharges directly and undamped into the Clutha River system rather than into one of the major lakes. As a result it has a disproportionate effect on main stem peak discharges, and its considerable sediment load is carried more or less directly as far as the hydro dams (bed load), and beyond in the case of some of the suspended load. **Photograph 6** shows the Shotover River Delta.

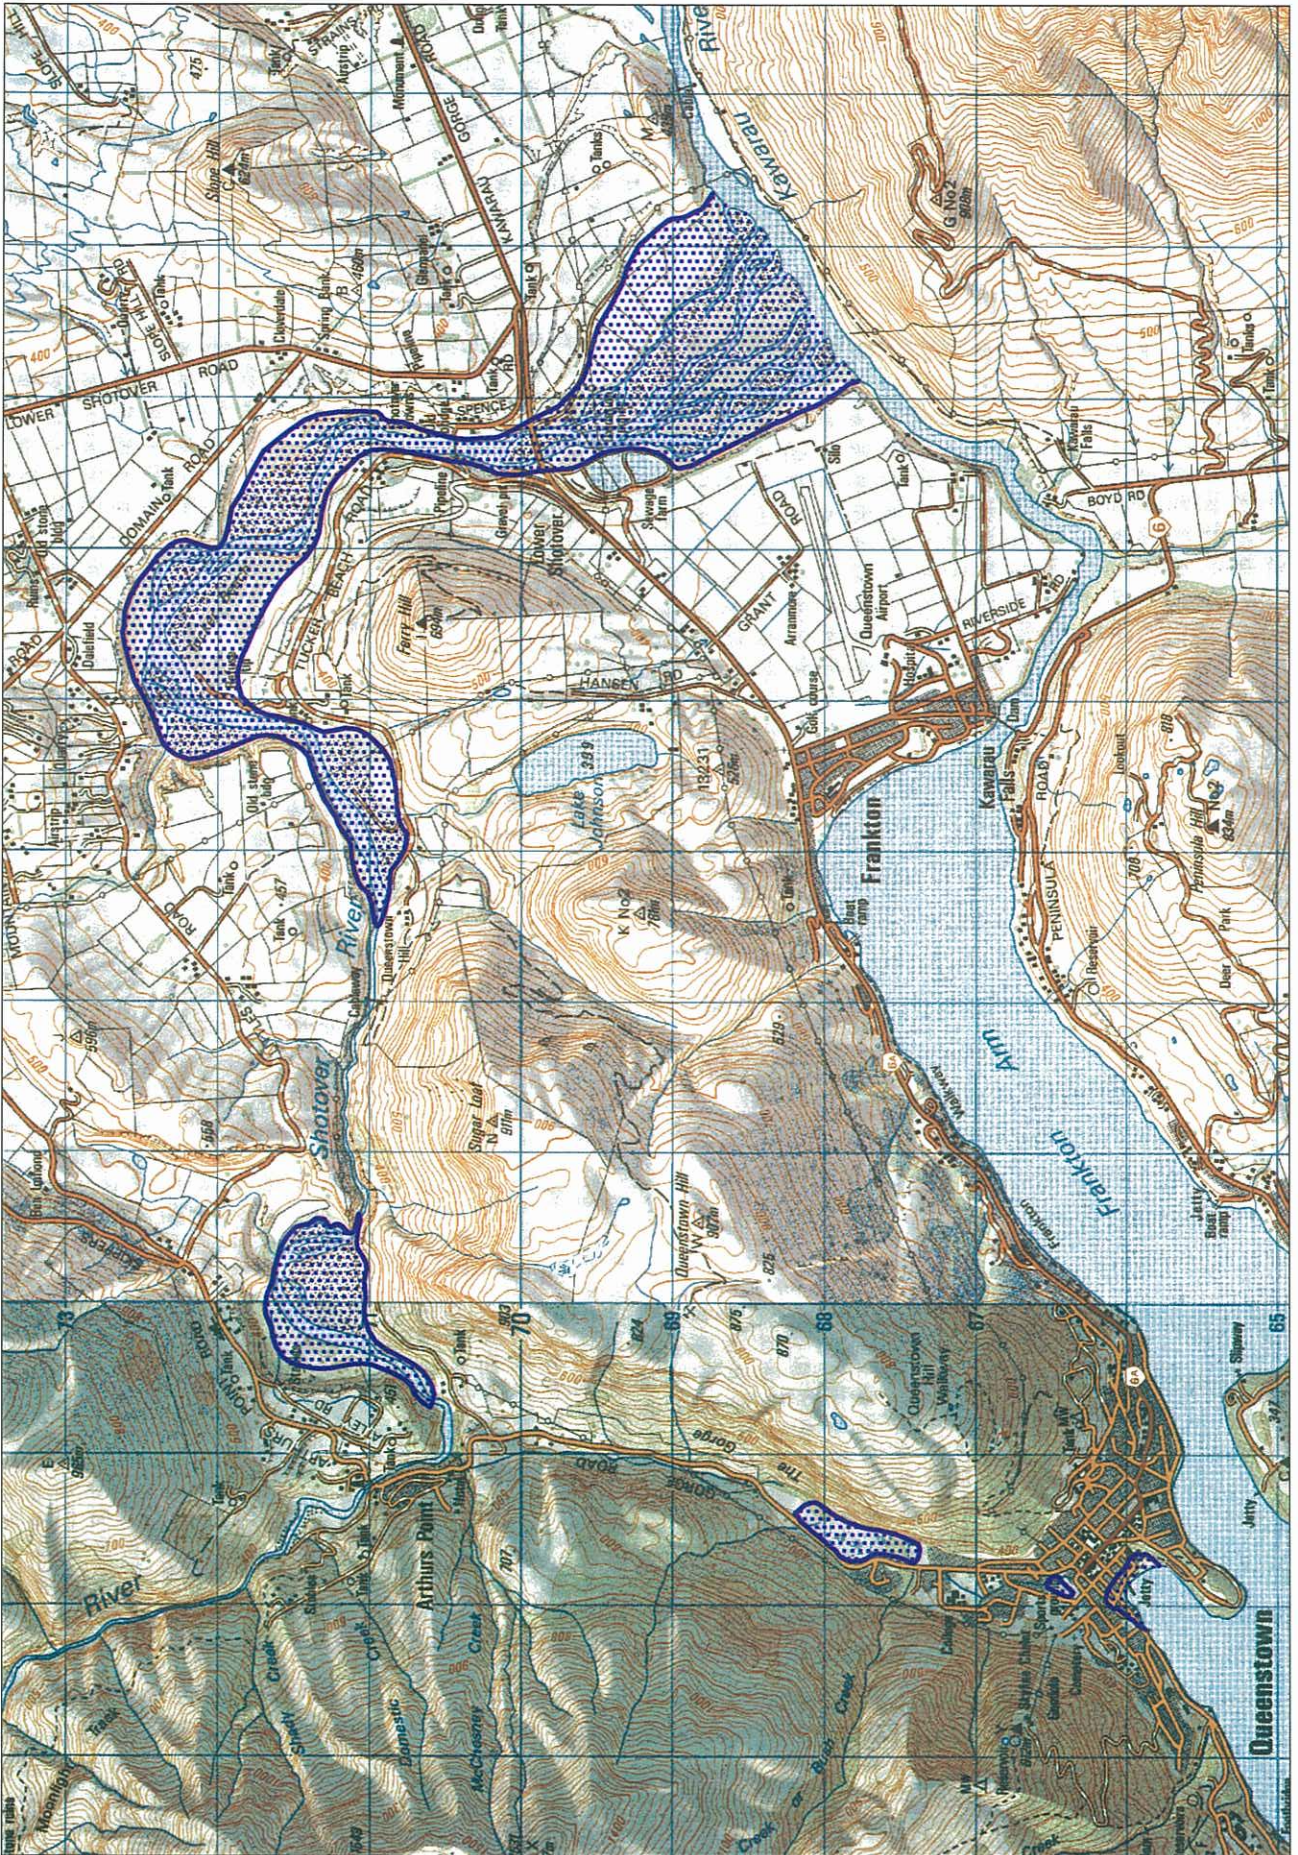
Figure 8
Shotover River and Horne Creek Floodplain

Many hectares of once fertile land on the left bank of the river immediately upstream of the Kawarau confluence have been lost to river erosion and the effects of an aggrading gravel fan over the past 2-3 decades. River training works that would have protected these areas were deferred in the mid-1970s as there were concerns that the piers of the new highway bridge might be undermined by the scouring of the river bed, resulting from the works. Other flat areas in the Lower Shotover such as Tucker's and Big Beaches remain liable to inundation. Flood prone areas of the Lower Shotover are shown in **Figure 8**.

The ponding areas are shown in **Figure 8**.

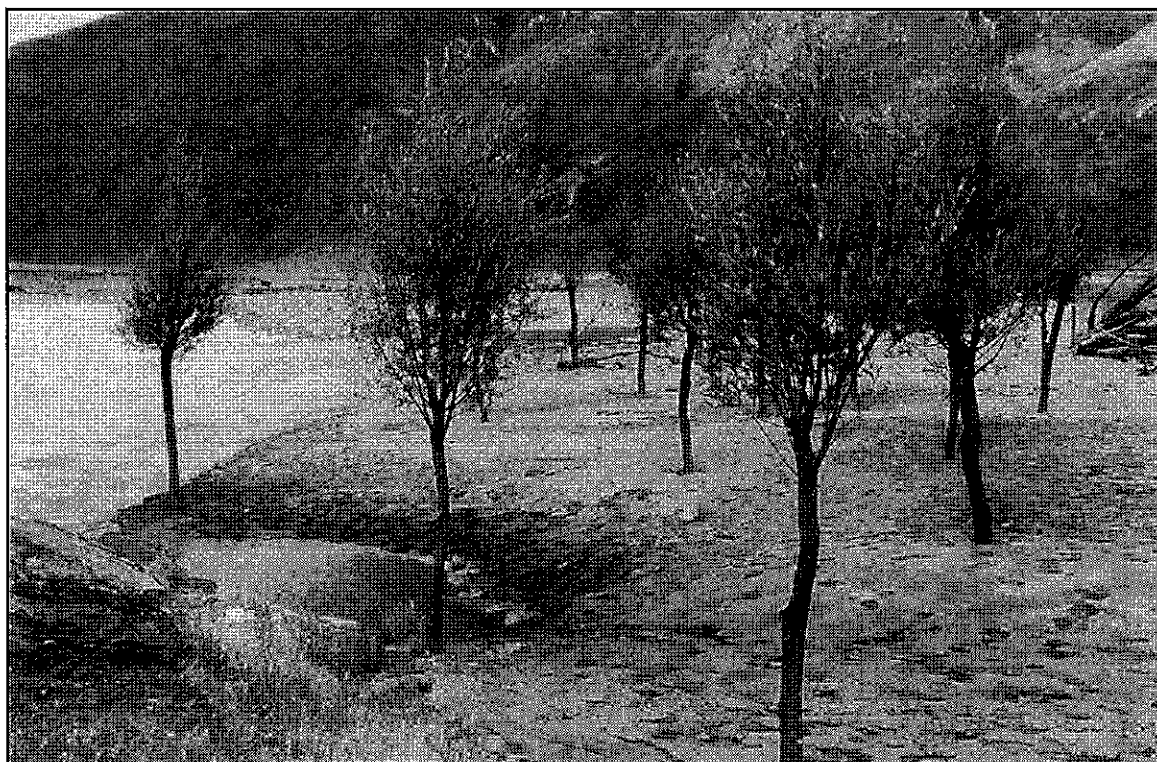
Photograph 8
Matukituki River Right Bank – Reclaimed Land Downstream of Training Works
(January 1994)

In an attempt to overcome such problems a training line of railway iron and walings was constructed downstream of Glenfinnan. These have been successful in reducing erosive attack on the right bank of the river by flow redirection and by building up a river terrace of silt and gravel, deposited during floods, on the landward side of the works.

area. In that time floodbanking has been carried out on the Carmel Burn, Leaping Burn, Boggy Burn and Phoebe Creek tributaries amongst others, and at many locations along the main river channel itself. Log lines, rock revetment work and live willow plantings have been extensively utilised as means of flood mitigation and debris control. **Photographs 7 and 8** shows works undertaken in the catchment.
